# Investigating and modelling of highly stressed firearms parts

**Abstract.** Recently, there have been too many Pulemyot Kalashnikova Modernizirovannyi (PKM) machine gun bolts that have failed during the firing process. Due to the increased temperature, higher propellant gas pressure, and thermal accumulation, the bolt body is exposed to sever circumstances for ablating, corroding, and erosion. In this paper, the reasons of failure of PKM bolts during firing were evaluated first based on metallurgical experiments. Then, analysing the failure is done by create an accurate finite element model of the bolt body, calculating the cyclic fatigue life and safety factor, determining the causes of failure and be verified showing that failure locations are exactly as shown in the photographic record. the original bolt dimensions were measured using laser scanning, and a CAD model of the bolt was created. Photographic records, visual inspection, chemical analysis, SEM, and hardness measurements, all these metallurgical experiments have been done. The stress distributions and fatigue behavior of the failed bolt are both determined using the Finite Element Method (FEM). This study suggests th

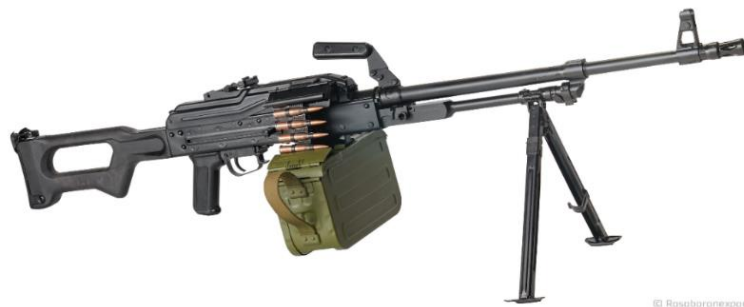
Figure 1. PKM 7.62mm Machine Gun [1].

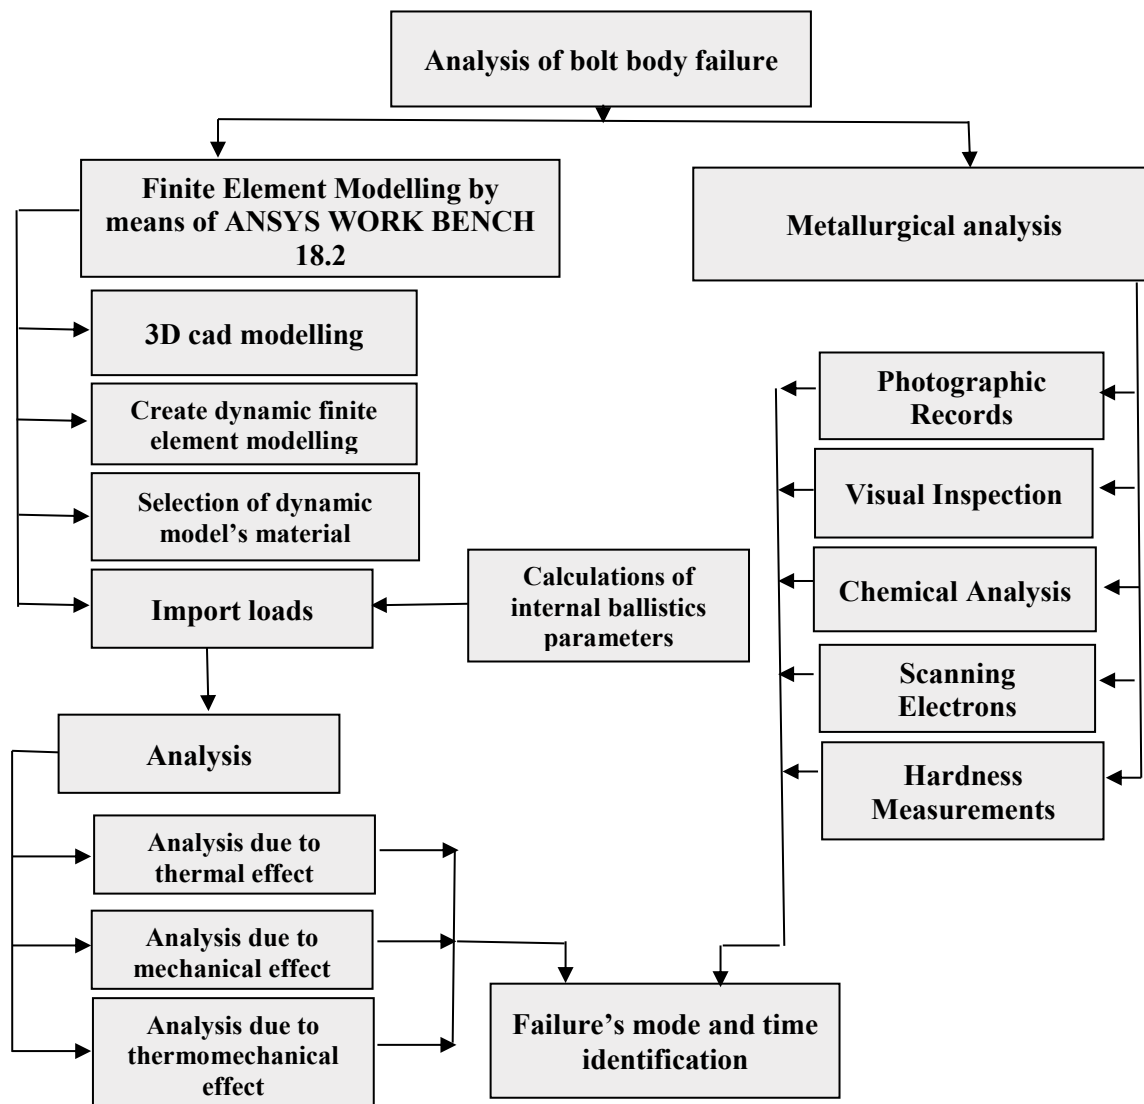
Figure 2. Analysis of bolt body failure procedures.

The main objective of this work is to create an accurate finite element model of the bolt body, analyse the failure of the bolt body by calculating the cyclic fatigue life and safety factor, determine the main cause of failure and verify that the failure locations are exactly as shown in the photographic record. Evaluating earlier researches that focused on the study of mechanical part failures. The sequence of analysis methodology of bolt body failure is as shown in 'figure 2'.

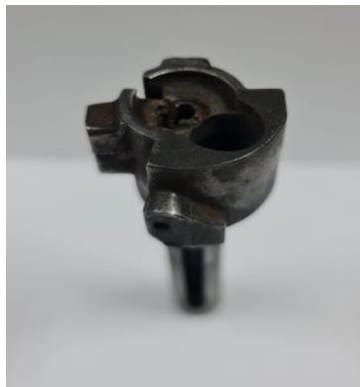
The bolt body, which is deteriorating while the other components continue to function as intended. 'Figure 3' depicts the failed bolt body that was the focus of my investigation whereas. Figure 4 depicts a new bolt body that hasn't been used yet this is evident to us from the failure that struck the bolt body's face (see 'figure 3'), which includes some segments with erosion and others with fractures. Another issue with the lug of the bolt body, which is the part that rotates the bolt body at a specific angle and causes the barrel lock to tighten when rounds are fired.

Figure 3. Failed bolt body.

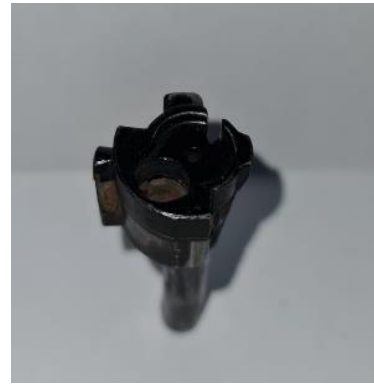
Figure 4. A new bolt body.

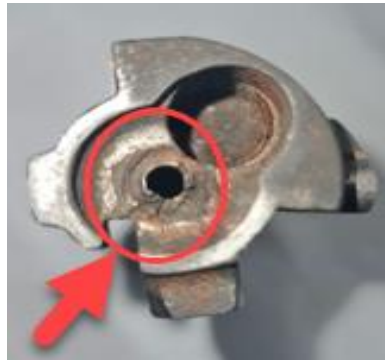
Figure 6. Close-up of a fractured bolt.

‘Figure 6’ makes it very evident that there are corrosion and cracking around the position where the firing pin moves to impact the bullet, which initiates the firing. Additionally, ‘Figure 7’ shows the locking lugs exhibit some wear, which affects the movement and completeness of the locking mechanism.

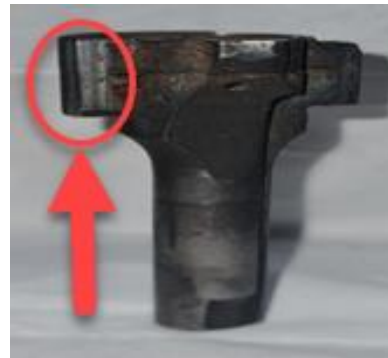
Figure 7. Failed bolt with worn lugs.

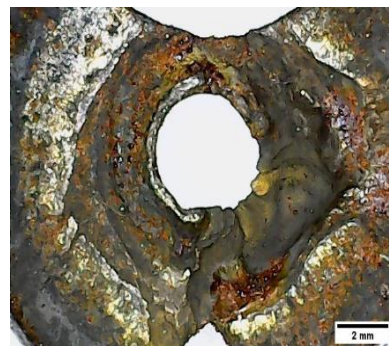
As shown in ‘figure 9’, obtained from the store were both visually inspected the new bolt body had a coating of paint on it, which was evident upon examination and was likely applied for storage purposes see. Regarding the failing bolt block, it was evident from it that use had worn away the paint covering and covered with corrosion (see ‘figure 8’).

Figure 9. A clear visual inspection of the failed bolt surface.

Through Visual Inspection, the location of the beginning of the crack is reached, which helped, during SEM's work, to quickly locate the crack, and the rest of the surface was completely oxidized and covered by corrosion.

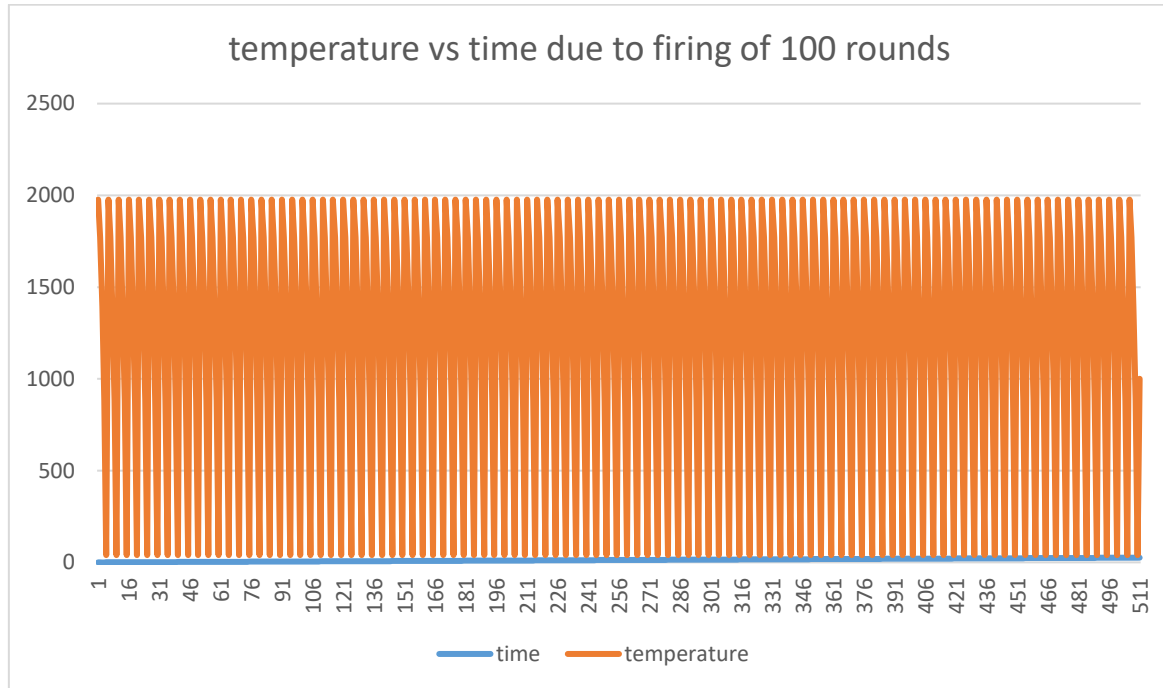
From the calculations of Internal Ballistics, the temperature starts from 2300 and decreases until it reaches 1300 degrees Celsius (see 'figure 15'). Cycle is repeated with each shot. Heat here is one of the main loads that affect the parts of the weapon and results in stresses that transfer and change with time. Therefore, the loads resulting from firing 100 rounds represents a transient thermal cyclic load in 25.751 sec as in the 'figure 15'.

Figure 15. Temperature changes over time due to firing of 100 rounds.

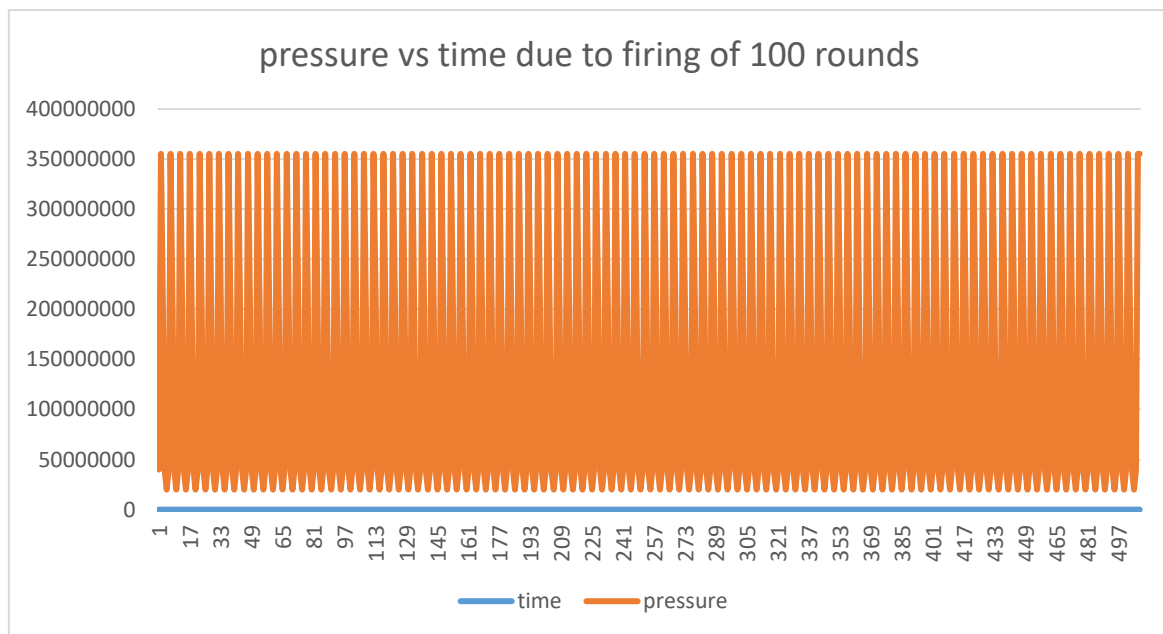
Heat is not only the load that results from the movement of the projectile until it exits the pipe, but there is pressure whose value changes with time and it represents a mechanical load transient that affects the bolt body and its value changes during one cycle from 30 MPa up to 355 MPa and decreases until it

reaches 30 MPa Pascal (see ‘figure 16’), and this cycle is repeated with each shot. The load resulting from the firing of 100 rounds is a transient mechanical cyclic load in 25.751 sec, as shown in ‘figure 16’.

Figure 16. Pressure changes over time due to firing of 100 rounds.
