## The Role of Inappropriate Outdoor Exhibition in the Biodeterioration of an Archaeological limestone Water Duct

The use of Inappropriate Outdoor Exhibition method is one of the main factors that accelerate the degradation of archaeological stone works. Here, we describe and diagnosis the biodeterioration of limestone water duct located in the courtyard of Sultan Qaitbay's mosque (1475). The used exhibition method provides the suitable environmental condition for biological grows. Several samples taken from various colors of microbial biofilm on the water duct surface were isolated and cultivated. The microorganisms were documented and analyzed using optical light microscopy (OLM), scanning electron microscopy with the energy dispersive X-ray (SEM-EDX) and high performance liquid chromatography (HPLC). The study showed that the main biofilm formers were fungi and bacteria. The fungi were identified as: *Aspergillus niger*-*Aspergillus terrus* – *Acremonium* sp. *Alternaria* sp. *Paecilomyces* SP. *Stemphylium*. Two kinds of bacteria are present (*Coccus* – and *Bacillus*). The organic acids produced by identified fungi were qualitative and quantitative assessed. The degradation c

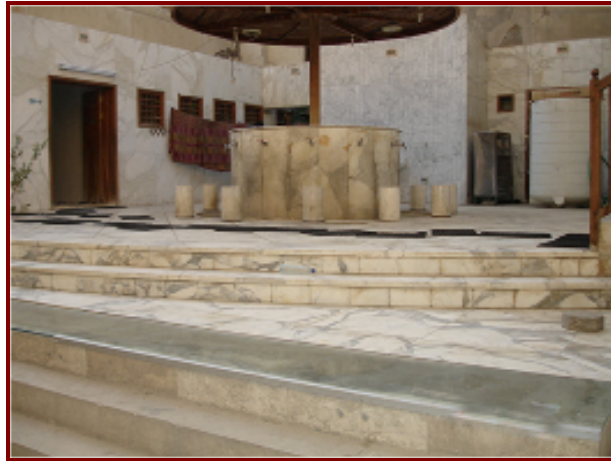
Fig.1 Shows the modern Mayda'a, which is 8 m. away from the studied limestone water.

The Qaitbay Medersa was founded by al- Malik al- Ashraf Abu an-Nasr Qaitbay in 1475. Sultan Qaitbay ruled Egypt from 1468 to 1496. The Medersa is located in Qal'at el Kabch street, beside el Sayda Zynab region, Cairo, Egypt. It has four façades and two main entrances, the western entrance and the eastern entrance. There is a minaret in its eastern corner. A basin for animal drink is subjoined to the western side of Medersa. The restoration works of Medersa were completed in 2006. In the northwestern side of Medersa there is an open courtyard containing modern Mayda'a, which is not belong to the original construction of the Medersa<sup>1</sup>. 8 m. away from the Mayda'a there is a limestone water duct. It measures 9.5 m long, 0.5 m wide and 0.35 m height [fig1].

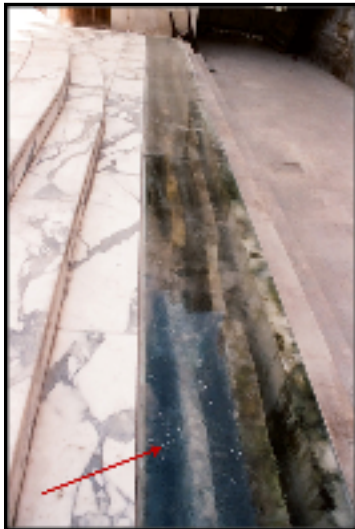
Fig.3 Shows the dense layers of biological colonization accumulated on the surface of the water duct. The arrow point to the water drops condensed on the glass surface.

The water duct is in very bad preservation state and shows typical decay phenomena of a surface subjected not only to the outdoor exposure but also to the unstudied human intervention. Very dense layers of biological colonization accumulated on the surface of the water duct [fig.3]. The accumulation of black, blackish brown, green and white stains of microorganisms caused the discoloration of stone surface [fig 4A]. Some vascular plants are growing in the bottom of the water duct [fig 4B]. The edges of the water duct are eroded because of the exfoliation and detachment of the superficial layer [fig 4C]. Salt efflorescence and incrustation are seen all over the surface of the water duct [fig 4D].

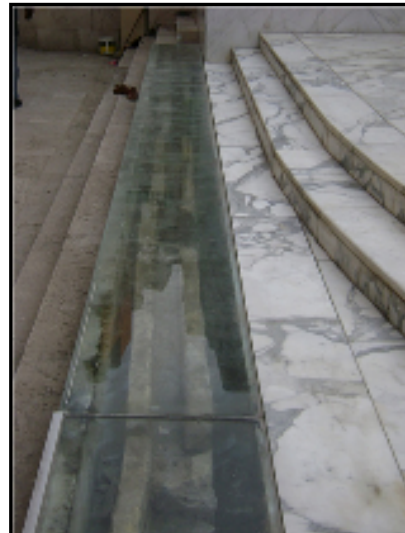
Fig.2 Shows the exhibition method of the studied water duct .

One of the conservation tasks is to preserve a limestone water duct, which was discovered during the restoration works, from to be buried under the accumulated dust and waste. The water duct is surrounded by modern limestone wall that is about 60 cm. height, 10 m long and 15 cm thick. This enclosure wall is covered with very thick glass (9mm thick) [fig2]. This man-made structure which aimed to protect the archaeological element was categorized as a semienclosed environment<sup>2</sup>. The microclimate of this kind of environment tends to produce many integral degradation factors that can be concluded as follow:

- Remove the glass cover that prevent air circulation and create a greenhouse effect. It was reported in the literatures that using a glass as a protective structure covering the entirety of the stoneworks accelerate the degradation process of the stone intended to be preserved<sup>34</sup>. In the planning of a permanent protective structure, one of the goals should be to guarantee microclimate conditions that, if not optimal, at least do not accelerate the process of degradation of the work. The coexistence and interaction of certain microenvironmental factors can trigger and encourage the development of organisms beneath the shelter. Consequently, the main objectives in the planning of a protective shelter that is efficient and that prevents biodeterioration should be<sup>35</sup>:

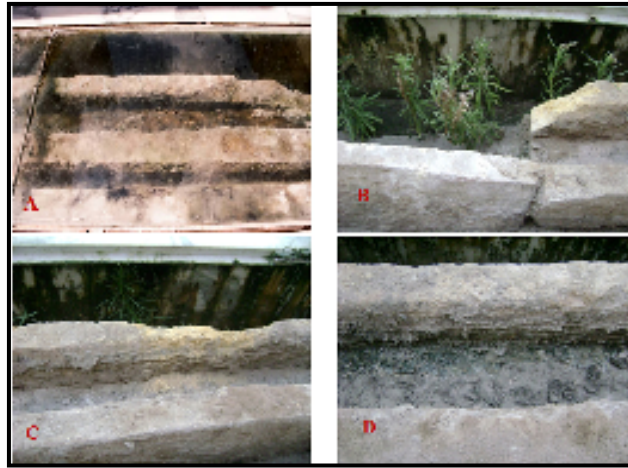
Fig. 4 Shows the degradation phenomena of the water duct. (A) Shows the discoloration of stone surface due to the accumulations of colored stains of microorganisms. (B) Shows the vascular plants growing in the bottom of the water duct. (C) Shows the eroded edges of the water duct due to the exfoliation and detachment of the superficial layer. (D) Show the black crust accumulated on the stone surface
