**11<sup>th</sup> International Conference  
on Civil and Architecture  
Engineering  
ICCAE-11-2016**

## **STATE OF THE ART REVIEW ON BRIDGES STRUCTURAL HEALTH MONITORING (TOOLS AND INSPECTION)**

**Ayman H. Khalil<sup>1</sup>, Khaled M. Heiza<sup>2</sup>, Omar A. El Nawawy<sup>3</sup>**

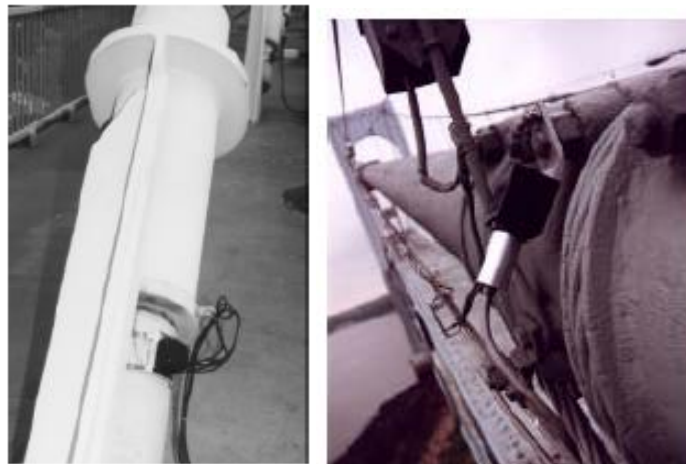
**FIGURE 2. MOUNTING ACOUSTIC EMISSION SENSORS ON POST-TENSIONED TENDONS.**

Transportation Authority of New York. The monitoring system was installed during a rehabilitation of the main cables (fig 2). This work involved removal of the circumferential wire wrapping, repair of broken wires and the application of corrosion-inhibiting oil to the wires. Consequently, it was possible to cut wires in the cable to test the system's recognition and location capabilities. Single sensors were attached to six cable bands, each 12.2 meter apart. An array of three additional sensors was placed around two of the cable bands to evaluate radial location capabilities. A portable acquisition system was set up at deck level and the testing was done while construction work was in progress. Six wires were cut within the monitored section in a blind test. The system correctly classified the events and located them longitudinally with errors ranging from 0.0 meter to 0.7 meter. Radial location using all four sensors on a cable band was accurate to within 7.5°. Acoustic events caused by steel chisels being driven between the wires were easily identified and filtered. It should be noted that the commercial name of the system is "Sound Print".

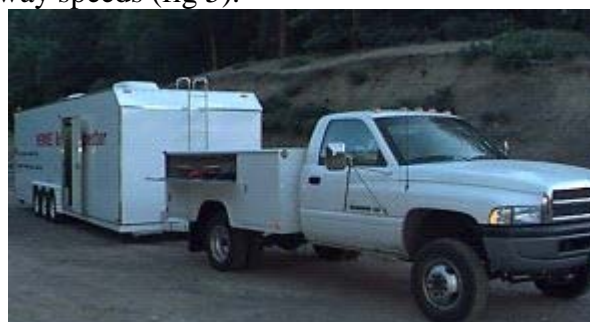
**FIGURE 5. RADAR IMAGING MOBILE SYSTEM (HERMES).**

Based on the test results, a system of using the radar-imaging concept was developed. It was developed by FHWA and Lawrence Livermore National Laboratory, as part of the FHWA's Nondestructive Evaluation Program. The system is called HERMES Bridge Inspector. The HERMES Bridge Inspector incorporates a 64-module antenna array, which is capable of scanning bridge decks at highway speeds, and a computer workstation with software to reconstruct high-resolution images of the interior of a bridge deck. The system uses synthetic aperture radar techniques (SAR) to reproduce 2-m wide images at a time. Unlike other radar-based inspection systems, HERMES collects data at very small intervals (as small as 30 mm), locates steel reinforcement, and detects corrosion-related delamination, voids, and debonds at a penetration depth of up to 300 mm. The HERMES equipment is housed in a trailer and can be easily towed at highway speeds (fig 5).

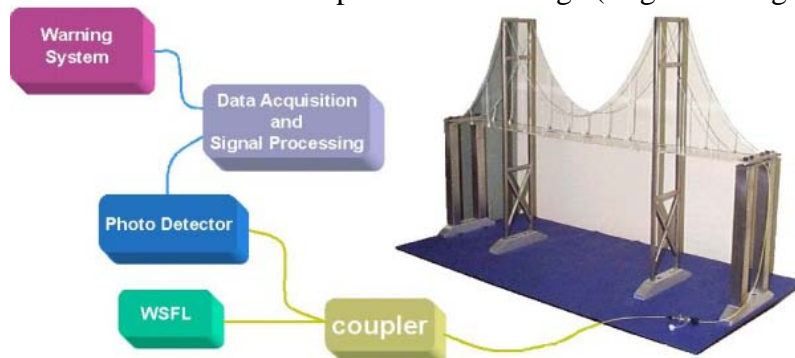
FIGURE 9 SCHEMATIC DIAGRAM OF SMART BRIDGE.

For verification of the system's performance, the experiments of static and dynamic strain measurement were carried out [20]. Four optical fiber sensors were used to monitor strains of a scale-down bridge span. The span of scale-down Bridge was made by acrylic plate. The instrumentation allowed issuing a warning sound when the bridge shows the response of near certain level of strain. This early warning system could give time to undertake remedial works on bridges before a catastrophic disaster. Fig 9 shows the schematic of the experimental setup for the test. The span of bridge was clamped at its ends. Four sensors were bonded on the lower part of the span using epoxy. Experiment was performed by applying the concentrated load at chosen points of the bridge (as given in fig 10).

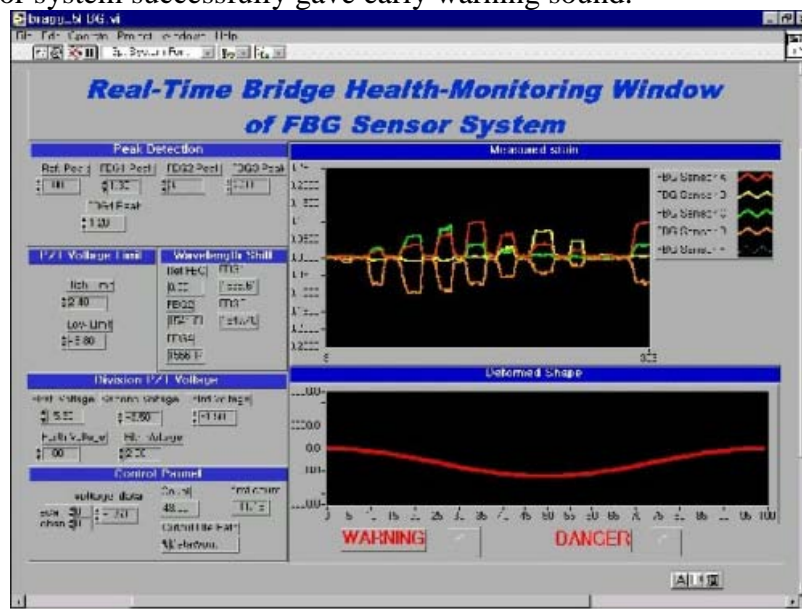
FIGURE 11 REAL-TIME STRAIN MONITORING WINDOW.

Fig 11 is a real-time strain measurement window by the signal-processing program. The window could monitor real-timely strain states of the sensors and inform user the dangerous state of the bridge by an alarming sound in the case that monitored strain exceeded a given threshold strain level. The real-time monitoring window has two charts showing strains and shape of the bridge span. First chart shows the strain history of four sensors when the vertical load moves discretely along the span of the bridge. Second chart shows a deflection shape of the bridge that is calculated using a clamped boundary condition and measured strains. The strains measured by the fiber optic sensors showed a good agreement with the strains calculated by a classical beam theory. When the bridge undergoes near threshold level of strain, the sensor system successfully gave early warning sound.

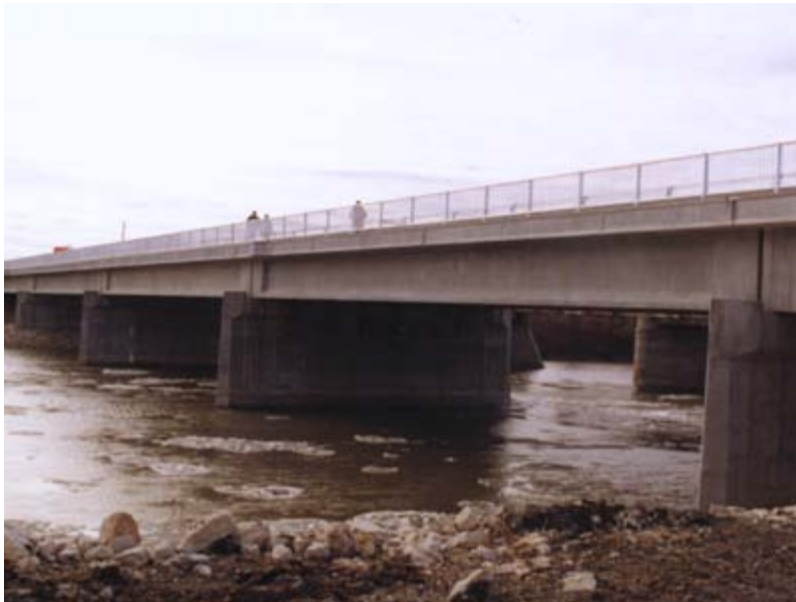
**FIGURE 12. OVERVIEW OF TAYLOR'S BRIDGE [23].**

Fiber optic sensors were utilized in the Headingly (Taylor) Bridge [23, 24] located on Manitoba Provincial Road 334 over the Assiniboine River, west of Winnipeg to monitor the performance of FRP materials (fig 12). Two types of carbon FRP reinforcements were used. Carbon fiber composite cables were used to pretension two girders while the other two girders were pre-tensioned using indented lead line bars. Two of the four girders were reinforced for shear using carbon FRP stirrups and lead line bars in a rectangular cross section. The other two beams were reinforced for shear, using epoxy coated steel bars.

The deck slab was reinforced by indented lead line bars similar to the reinforcement used for prestressing. Glass FRP reinforcement was used to reinforce a portion of the Jersey-type barrier wall. Double-headed stainless steel tension bars were used for the connection between the barrier wall and the deck slab. The bridge boasted a complex embedded fiber optic structural sensing system that allows engineers to compare the long-term behavior of the two materials. This remote monitoring was the key to acquiring data on FRP that would ultimately help it gain widespread acceptance. 64 single fiber optic sensors were used to monitor the bridge strains, loading and temperatures. The sensors were immune to electromagnetic interference and have long-term stability. The monitoring system provided a profile of the bridge with detailed information on its structural behavior as well as applied loads and environmental effects.

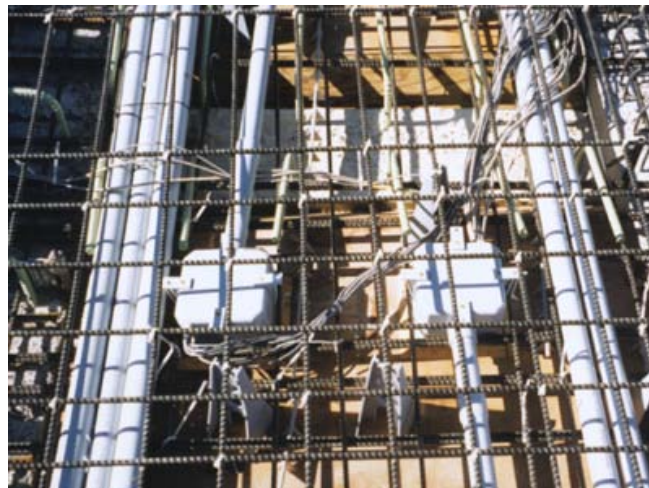
**FIGURE 13. SENSORS EMBEDDED IN THE DECK OF TAYLOR'S BRIDGE [23].**

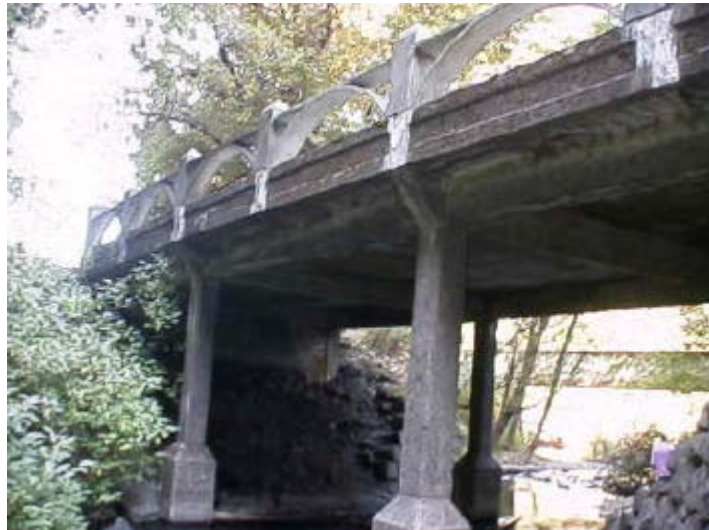
**FIGURE 14 HORSETAIL BRIDGE BEFORE STRENGTHENING.**

Seim et al. [25] reported that the Horsetail Falls Bridge (see Figure 19) was used as a pilot project to answer two key questions: (1) could a bridge be repaired and strengthened with FRP composites on critical elements, and (2) how the FRP would perform in the long term. In an attempt to answer these questions, fiber optic strain sensors were embedded into the structure (fig 14). Preliminary data were obtained and the bridge would be monitored for the next few years.

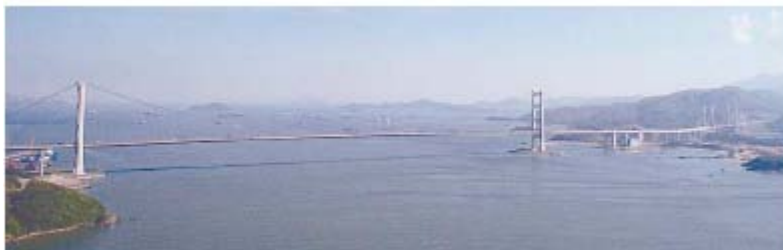
**FIGURE 16. TSING MA BRIDGE.**

A GPS-based system is currently used to monitor structural integrity of the Tsing Ma suspension bridge in Hong Kong [27]. The Tsing Ma Bridge, which spans 1,377 meters across the Ma Wan shipping channel, is the world's longest span suspension bridge carrying both road and railway traffic (fig 16 and fig 17). The Tsing Ma Bridge was constructed at a cost of around \$7 billion to provide high-speed car and rail connections to the Hong Kong International Airport.

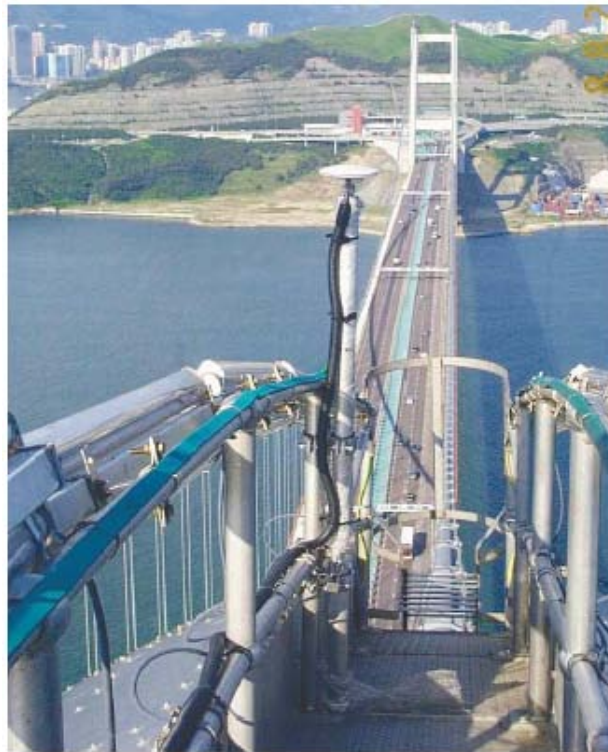
**FIGURE 17. TOWER TOP RECEIVER ON TSING MA BRIDGE.**

The GPS monitoring array, includes 29 high-precision GPS receivers, a Continuously Operating Reference Station (CORS), a central monitoring and control facility and a dedicated fiber-optic data communications network. The dual-frequency GPS receivers are being mounted on the Tsing Ma suspension bridge and the adjacent Kap Shui Mun and Ting Kau cable-stayed bridges. The GPS receivers are designed to measure their exact positions with millimeter-level accuracy, using signals from the orbiting GPS satellites and error correction data transmitted from the GPS reference station. The position data from each receiver will be transmitted at a rate of 10 times per second to the central monitoring facility via fiber-optic cables. The GPS-based monitoring system will operate automatically 24 hours a day, providing instantaneous 3D measurements of structural displacement due to environmental and applied loads, such as wind, temperature, seismic and traffic loads.
