Military Technical College
Kobry El-Kobbah,
Cairo, Egypt

8th International Conference
on Civil and Architecture
Engineering
ICCAE-8-2010

Earthquake Performance Upgrade of Infilled Nonductile RC Frames With External Mesh Reinforcement and Plaster

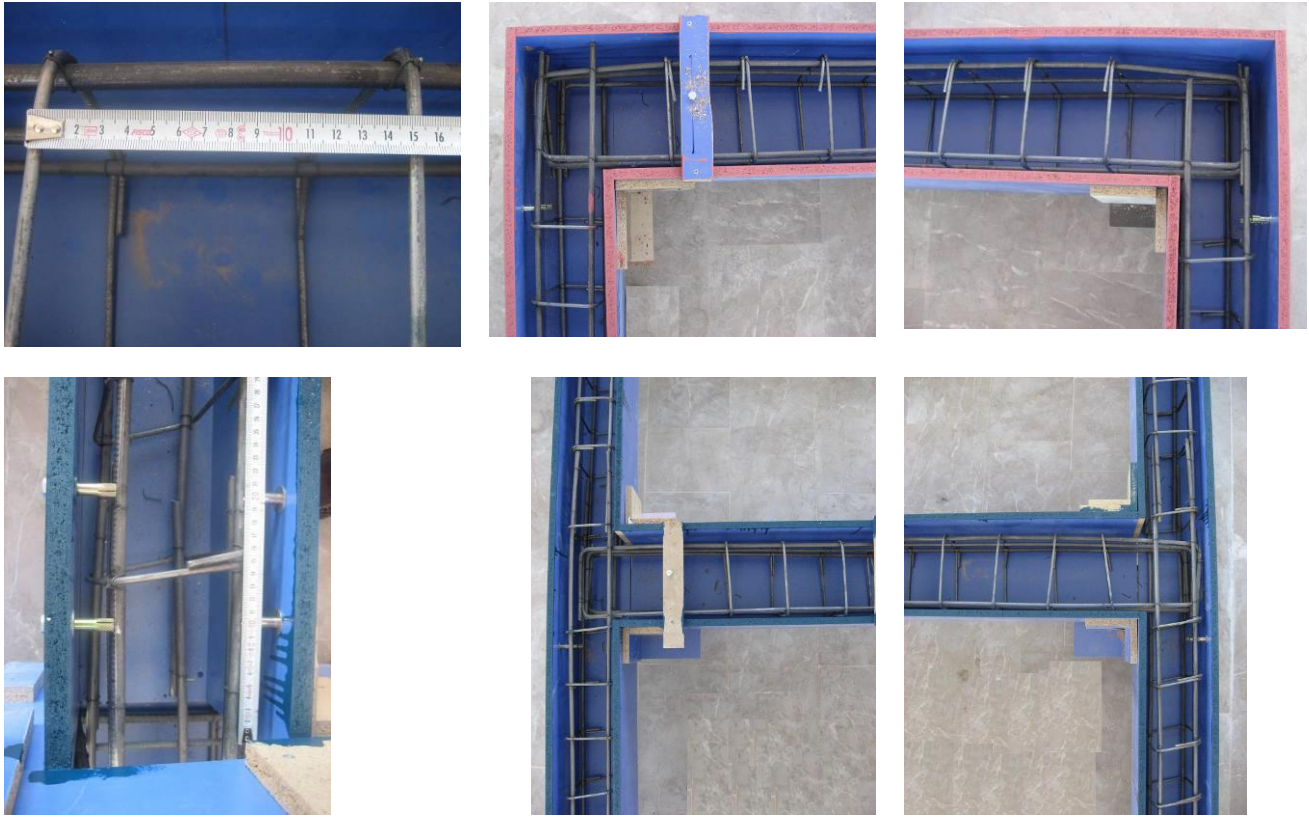
In the experimental program totally six specimens were tested. First two specimens (RFB1 and RISPS) contain no strengthening. Specimen 1 (RFB1) was the bare frame with no infill wall and used as reference specimen. The second specimen (RISPS2) was also reference specimen with ordinary infill wall. The other specimens were strengthened by introducing external mesh reinforcement and plaster over the existing brick infill wall. The mesh reinforcement was consisted of 16mmx16mm square meshes. The diameter of the mesh was $\phi 1.1$. The yield strength of the mesh reinforcement is 340 MPa and ultimate strength is 420 MPa.

Figure (2) Reinforcement details of the specimen

The connection between the existing frame and the infill was achieved by means of steel dowels that were made up of 10 mm diameter bars embedded into columns and beams. These dowels were expected to transfer the shear forces from beam to the infill wall. On the inner faces beams and columns, holes were drilled and cleaned with pressured air. The depth of the holes equals to 10ϕ . The external mesh was applied on the inner faces of the wall panels and epoxy was injected in to holes and dowels were inserted into the holes. Finally plaster prepared according to the mix proportion given in the Turkish Earthquake Code is applied on the surface of the mesh-wall composite (Figure 3). The specimens have the common property of weakly connection between the frames and the infills. Blocks were laid such that their holes were oriented vertically. Special $\frac{1}{2}$ scaled perforated clay bricks were used. For strengthened specimens first dowel holes were drilled and mesh reinforcement placed, finally dowels were anchored. At the last stage plaster was applied on the surface of the wall-mesh interface. The joint mortar, made of cement, lime, and sand in the proportion 1.0:0.65:6.6 was used to construct the brick masonry wall. Frames with low compressive strength were constructed. 15-MPa.

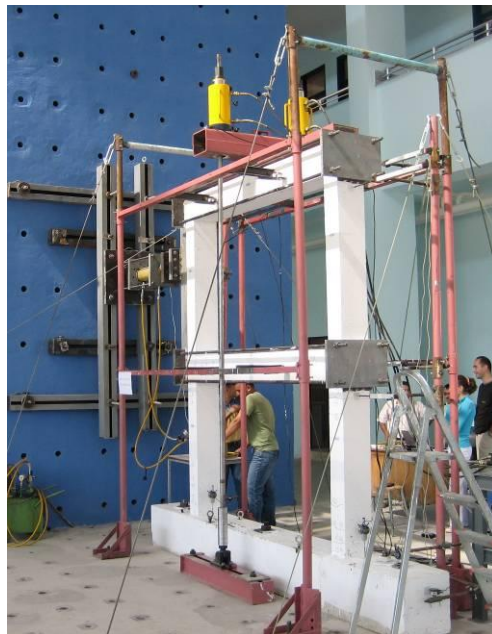
Specimen 1 was the reference specimen and contained no infill. The reinforcement details of the specimens were not in accordance to the Turkish Earthquake Code and a nonductile frame was tried to form. RFB1 was tested to understand the bare frame capacity (Figure 5).

Figure (5) Reference empty frame RFB1

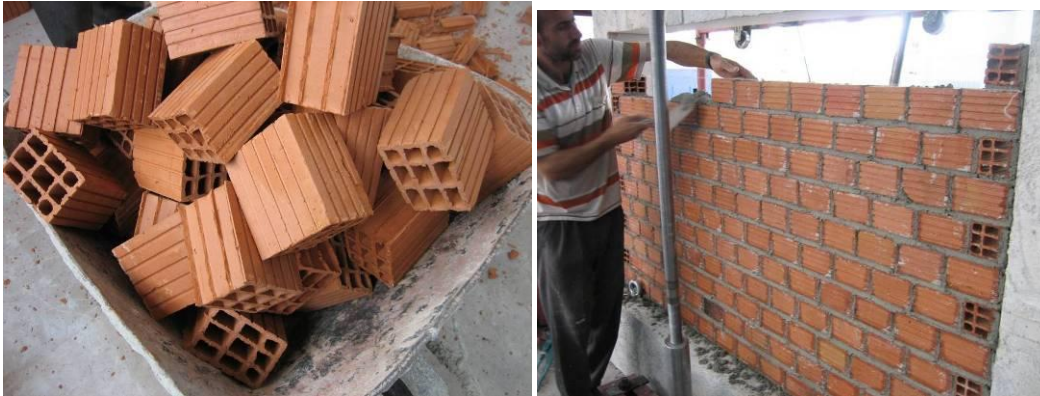
Second specimen (RISPS) tested was the reference specimen with unreinforced infill wall. This specimen contained no strengthening and tested to understand the reference behavior of the infilled original frame. The reinforcement details and the quality of the concrete were same as the RFB1. Special ½ scaled perforated clay bricks were used with ordinary mortar. Bricks were laid such that their holes were parallel to the horizontal plane (Figure 6). This application is common in Turkey for external walls of the framed structures. The infill walls were not constructed on the symmetry axis of the frame for simulating exterior walls of the building.

Figure (6) *1/2 scaled bricks were used with ordinary mortar*

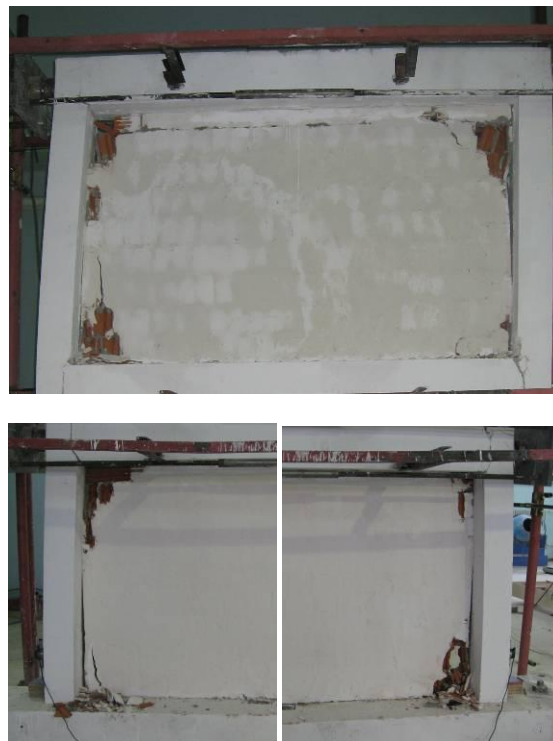
The failure mode of the infill wall was the corner damage and crushing of the wall panel. Bottom storey wall panel damaged more than the upper one. After the infill was crushed at the upper corners due to diagonal compression, the specimen lost its lateral load carrying capacity and thus, failed. The representation of the failure mode of the wall is given in Figure 7.

Figure (7) *Failure modes of the wall portions*

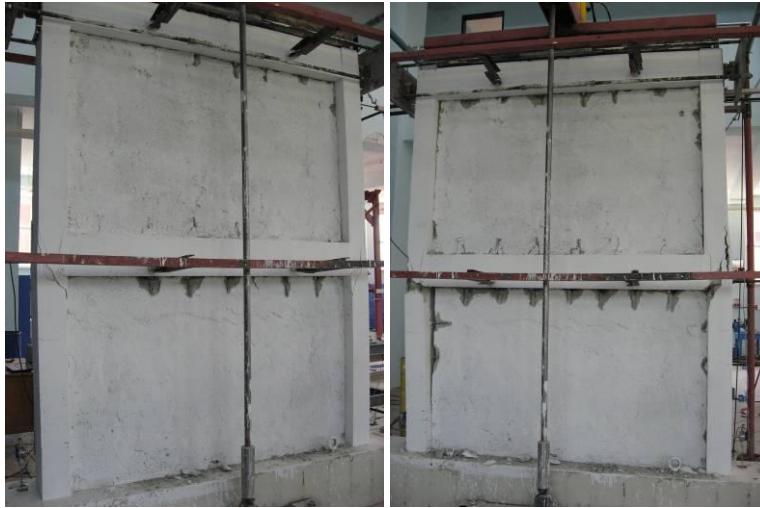
cracks were observed on RC members. Specimens SP2, SPS1 showed similar behavior and failure modes. The first cracks over the infill observed on the dowels. A similar but slower type of failure was observed like SPS1. As the applied cycles and displacements increased, disintegration between dowels and plaster become serious. This disintegration dropped the lateral load capacity of the frame (Figure 9).

Figure (9) Failure mode of the specimen SP2

The fourth specimen SP2 was strengthened using the results of the specimen SPS1. The thickness of the plaster was increased and applied as 20 mm. Increase in the plaster thickness in specimen SP2 improved stiffness as compared with Specimen SPS1. This specimen showed higher ultimate load than the specimen SPS1. Again initial flexural

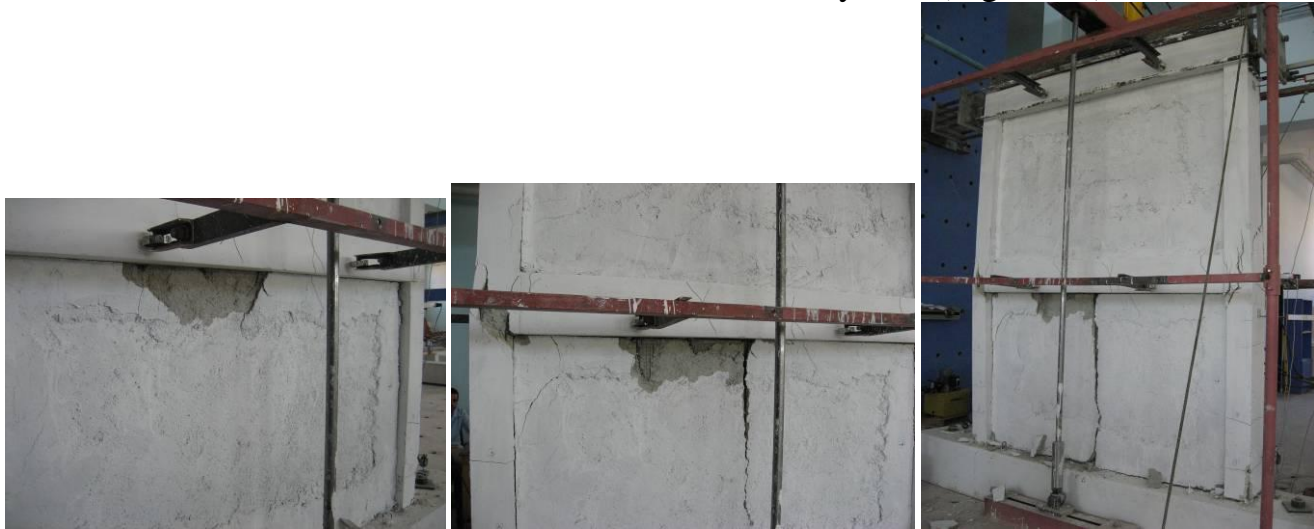
For specimen SP3, plaster thickness was chosen as 30 mm and also the strength of the plaster was increased to 30 MPa. Since the dimensions of the mesh were smaller than the dimensions of the brick area, two pieces of mesh were applied over the brick wall. The splice line was on the middle of the beam. Two meshes were spliced 300 mm at the junction point. Flexural cracks initiated and concentrated at column lap splice regions. During the testing, again several cracks were observed on the dowel points but no shear failure was occurred. Instead, the splice of the mesh reinforcement line on the middle was torn. The success of proposed strengthening method mainly depended on the connection provided between the frame and the infill. The load carrying capacity of the specimen dropped after the failure was observed. This type of failure progressed more slowly than the failure observed in specimens SPS1 and SP2. The test photos of the SP3 are given in Figure 10.

Figure (10) Failure mode of the specimen SP3

Thickness increase in specimen SP3 showed significant improvements in strength, stiffness and energy dissipation capacity relative to SPS1 and SP2. Results from specimen SP3 test show that the proposed composites with 30 mm plaster thickness application provide more robust connection and can successfully enhance the original structure. But in this case another failure mode was observed and the external mesh reinforcement suffered anchorage problem.

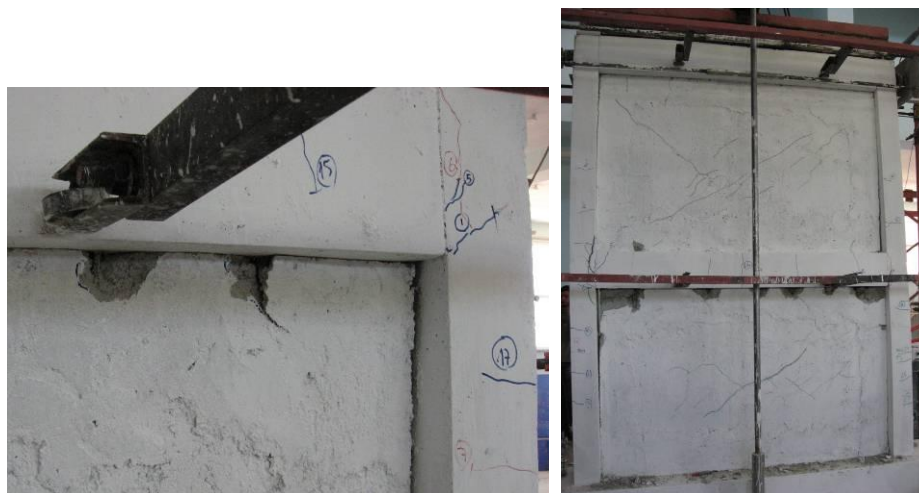
After a splice failure in SP3, and shear failures in SPS1 and SP2, the mesh reinforcement of the SP4 was doubled with same plaster thickness with SP3. Combined type of failure mode in SP4 was observed. Bond deterioration between dowels and the plaster was initiated but not progressed further. Corner crushing of the wall panels were observed. Inclined shear cracks were initiated. Ultimate load capacity of the SP4 was noticeably higher than the other specimens. The cracks over the plastered mesh panels

showed a load distribution between the wall and frame system (Figure 11).

Figure (11) Failure mode of the specimen SP4

In specimen SP4 where the anchorage length of the external reinforcement was increased, debonding of the shear keys initiated but didn't progress further. No anchorage problems were encountered for external reinforcement. Instead, infill wall joints were crushed at the upper and lower corners of the infill wall. Also cracks were spread over the reinforced wall panels. Specimen SP4 exhibited significantly higher ultimate strength and higher stiffness than the others.
