REHABILITATION OF REINFORCED CONCRETE BUILDINGS AFFECTED BY 2023 TÜRKİYE EARTHQUAKE

olabi, abdullah melik

MSc Student, civil engineering department Hasan Kalyoncu universite Gaziantep ,
Türkiye

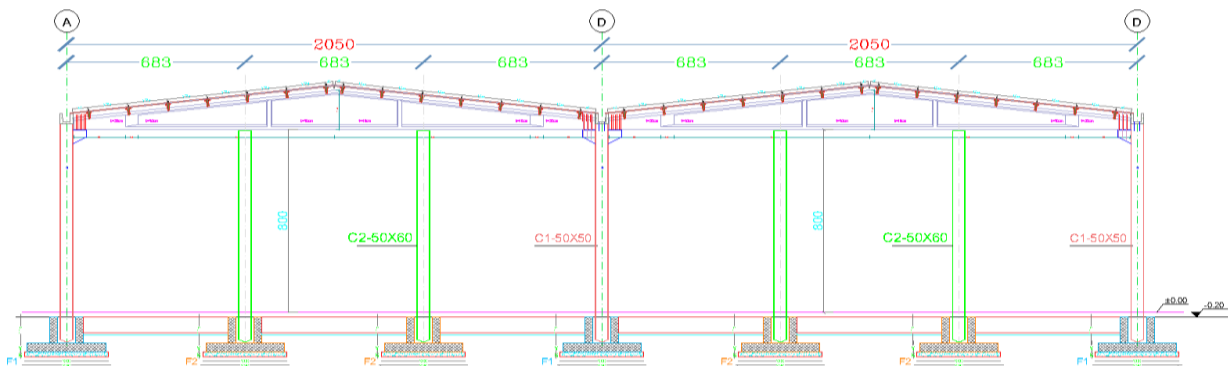
Fig 14: scanned building section

Description of Damage: Columns collapse under the influence of horizontal force torque

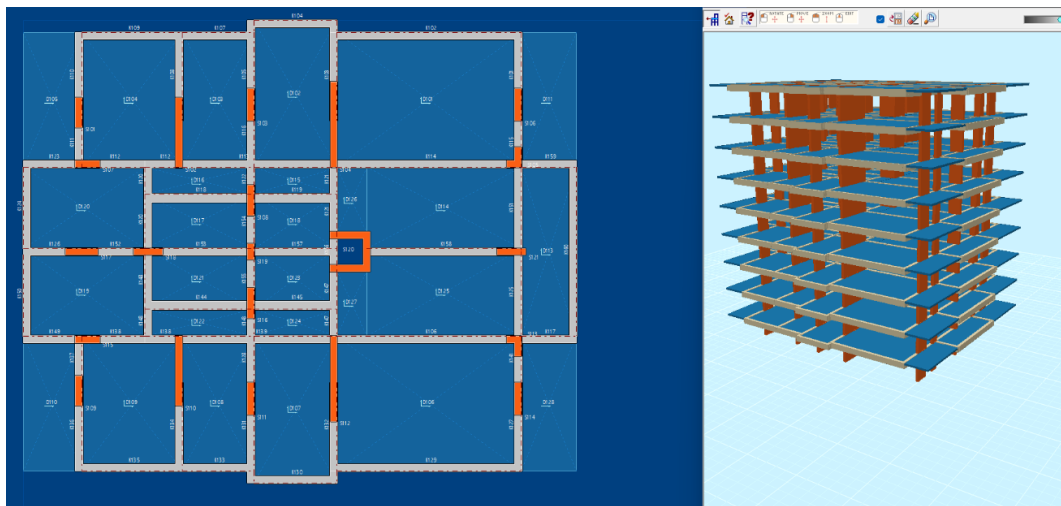
Fig 17: computer modelling (STA4CAD).

After entering all the data into the program, analysis and design were conducted. The results related to the damaged element were obtained and compared in the current situation.

The damaged element withstands the required moments with the dimensions present in reality. However, there are differences in terms of reinforcement between the design results and the results implemented in reality. A comparison table was created below for

This comparison highlights that while the dimensions of the damaged element align with design expectations, there are discrepancies in reinforcement between the design and implementation phases.

It is noted that failure occurred in the Y-axis direction, resulting from the bending moment. Therefore, it is necessary to compare the longitudinal reinforcement and stirrups.

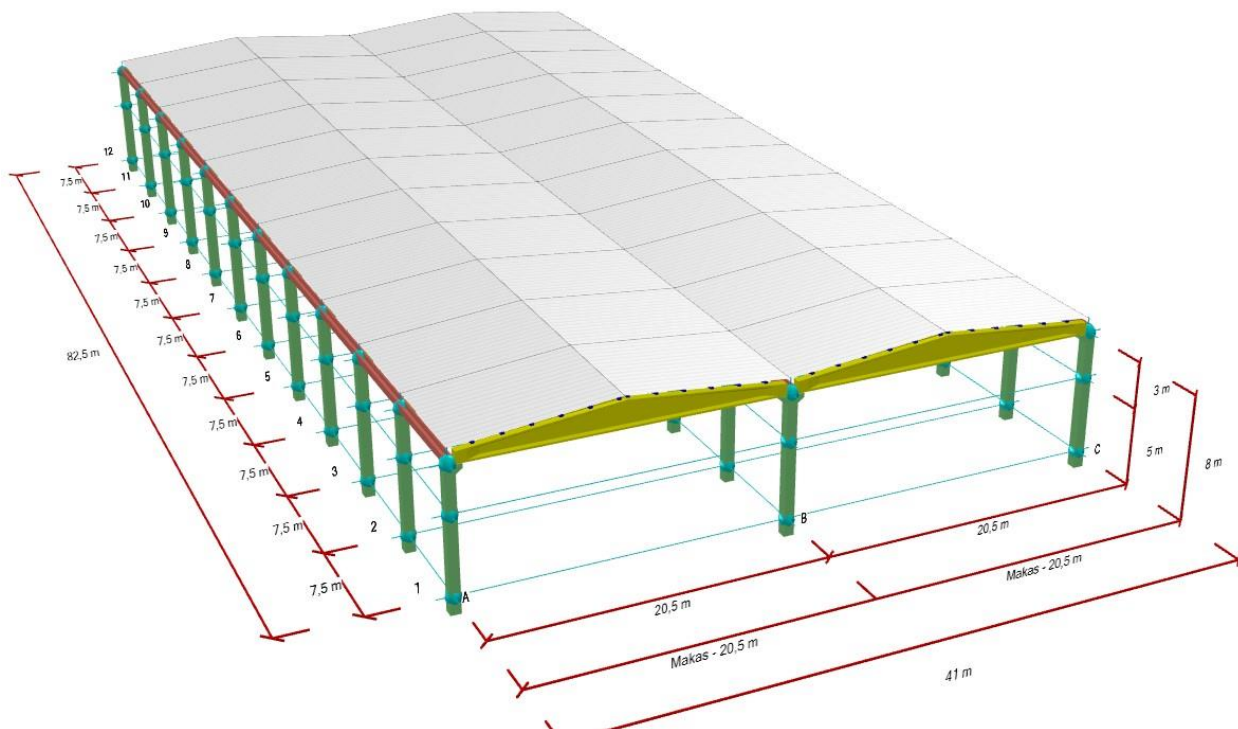
Fig 19: computer modelling for second sample (FAB2018).

seismic code requirements. It is particularly noteworthy that the confinement region of the ties terminates very close to the ground, not exceeding 50 cm. And there is a shortage in both the number and diameter of the main reinforcement bars. This likely explains the collapse of the columns under seismic forces.
