The Effect of Bad Heat Treatment Technology on Failure Mode of Armor Steel Sheet under EN1522 Ballistic Test

Abstract

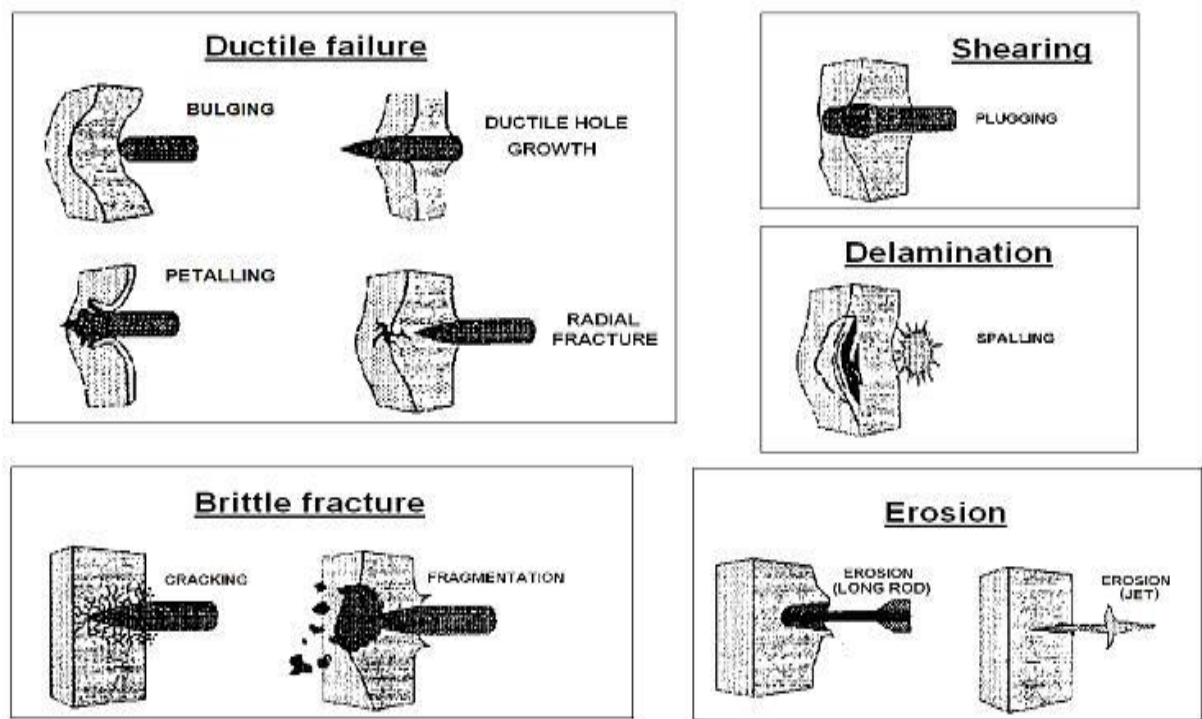
Fig. 5 Failed location at the rear side of 6mm armor steel sheet [9].

mode, or fragmentation mode, as explained in Fig.5. Based on the deformation at the horizontal axis, it can be observed that the bending strength of non-failed area is higher than bending strength on failed area. Regular bending angle is clearly observed at non-failed area, while irregular bending angle is observed at failed area. The reduction of thickness at non-failed site reaches 16%, while it is 3.3% at failed locations, as given in Fig.6. From these observations and calculations, it should be clear that there is less elastic strength structure has been formed at the failed area, which can reduce the plastic strength of this area to its ultimatum.

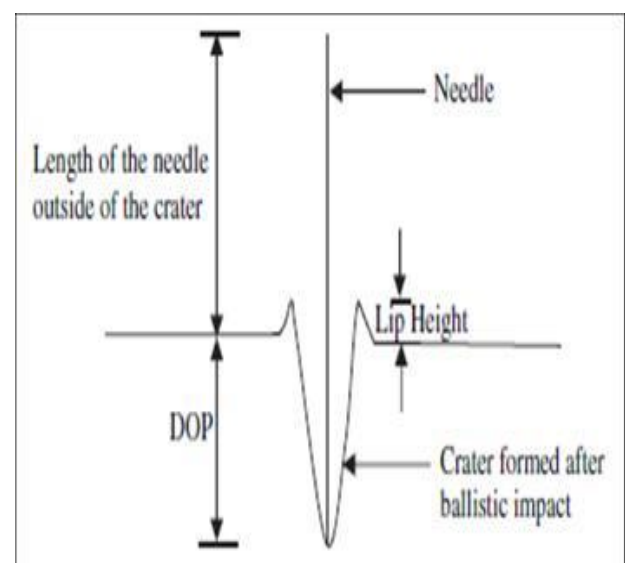
Fig. 7 Depth of penetration at non-failed sites [10].

Non-failed sites at the armor steel sheet have another indication on the high strain rate deformation occurred by the projectile at the ballistic test. As shown in Fig.7, Depth of penetration can be calculated for non-failed sites. In fact, the change of depth of penetration is another sign on the discrepancy in constituent phases among the investigated sheet. It was found that the depth of penetration is 1.2, 1.95 at non-failed sites, which represents huge discrepancy of the ballistic performance at different sites of armor steel sheet 6mm. Certainly, the phases identification methods, using SEM, and XRD will explain the disparity in ballistic performance among the investigated armor sheet.

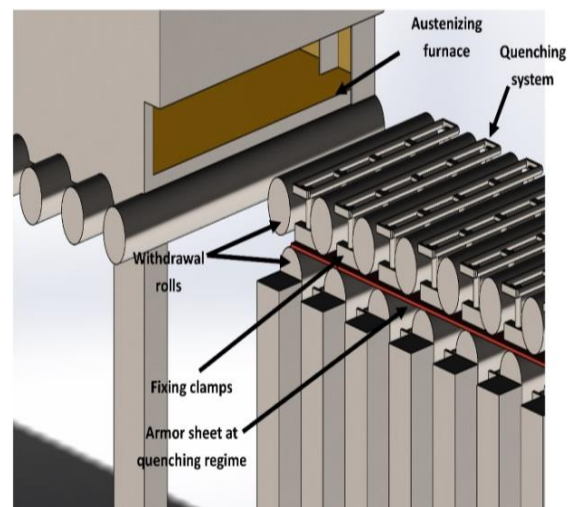
Fig. 24 Illustration diagram of the quenching regime of the armor steel sheet at the industrial site.

By using of the geometry of the armor sheet, the dimensions of the austenizing furnace, the dimensions of withdrawal rolls, and the clamping system, FEA based on Solid work package has been used for simulating the transient heat transfer mechanism at the production site through 7 seconds (the actual time before clamping and quenching), as shown in Fig. 24,

25, and 26. It is observed that much reduction in the austenizing temperature at the armor sheet can be established, regarding to its low modulus profile (high ratio of surface area: volume). In addition, at fractions of seconds the temperature of the studied sheet has been reduced rather than the austenizing temperature 830oC by more than 100°C, which will affect directly on the percentage of ferrite and martensite. In addition, it can be observed the high fluctuation of temperature at the same time among the surface of the armor sheet.
