EVALUATING THE SHEAR BOND STRENGTH OF REBONDED CERAMIC BRACKETS AFTER USING THREE DIFFERENT TECHNIQUES FOR ADHESIVE REMOVAL: AN IN-VITRO STUDY

Abstract

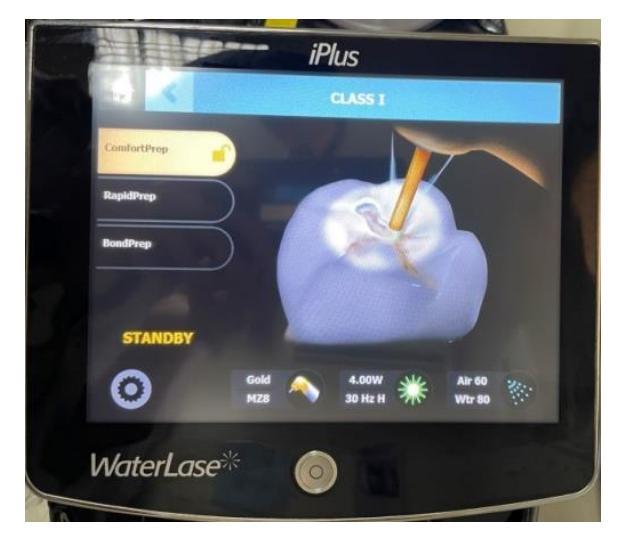
Figure (1): Er,Cr:YSGG laser (Waterlase, Iplus, Biolase technology, CA, USA)

Removal of the adhesive resin composite was done using Er,Cr:YSGG laser (Waterlase, Iplus, Biolase technology, CA, USA) emitting a wavelength of 2780 nm, with average power of 4 W; repetition rate, 30 Hz; pulse duration, 60 μ s; energy, 250 mJ; energy density, 49.7 J/cm²; water, 80%; air, 60% in non-contact mode (2 mm away); and sweeping motion (Figure 1). Tip used was 800 µm in diameter removed from the fifteen brackets [8]. (MZ8) until resin composite was completely

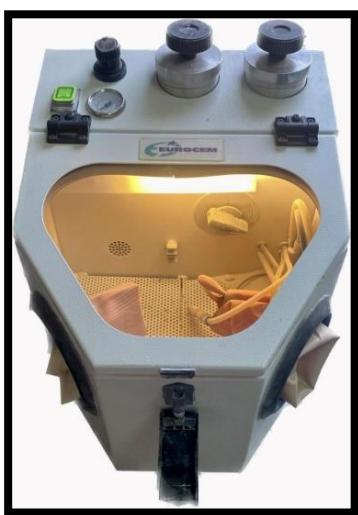
Figure (2): Eurocem sandblasting machine

Removal of the adhesive resin composite was done using the sandblasting machine (Eurocem s.r, k, Milanese, Italy) (Figure 2). The bracket bases were subjected to 50 µm aluminum oxide particles, with a 5 mm distance away from the sandblasting handpiece. Each bracket was sandblasted for 40 s until resin composite was completely removed from the fifteen brackets [8].

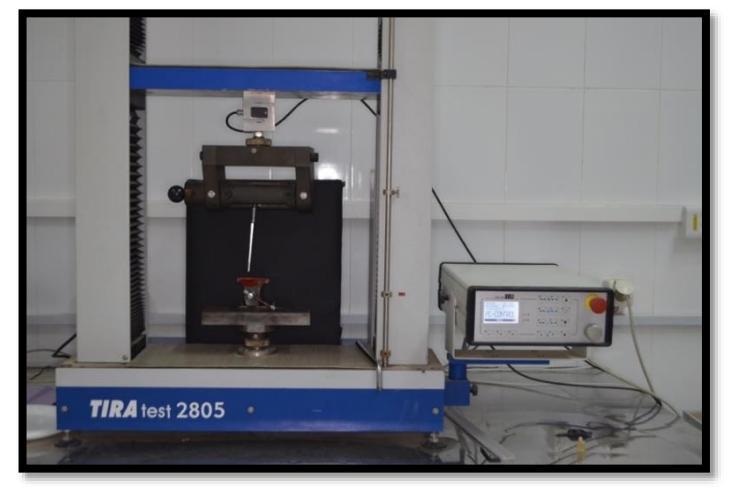
Figure (3): TIRA test 2805 shear bond testing machine

Blocks with bonded ceramic brackets were separately placed in a holding ring positioned in the lower jaw of the universal testing machine (**TIRA test 2805, Tirs GmbH, Eisfelderstrabe 23/25 D-928, Schalkau, Germany**) (**Figure 3**). The SBS test was carried out with a universal testing instrument. Each sample was secured in the lower part of the machine so that the shear force could be applied parallel to the bracket base. The samples were stressed in an occluso-gingival direction with a crosshead speed of 1 mm per minute (mm/min). The blade reached the tooth bracket interface and stopped as soon as debonding occurred.

The fracture / breakage measurements were recorded on the TIRA machine in Newtons (N). The Bond Strength, in megapascal was calculated by dividing the debonding force (N) by the bracket base surface area (mm2). (MPa = N/mm2).

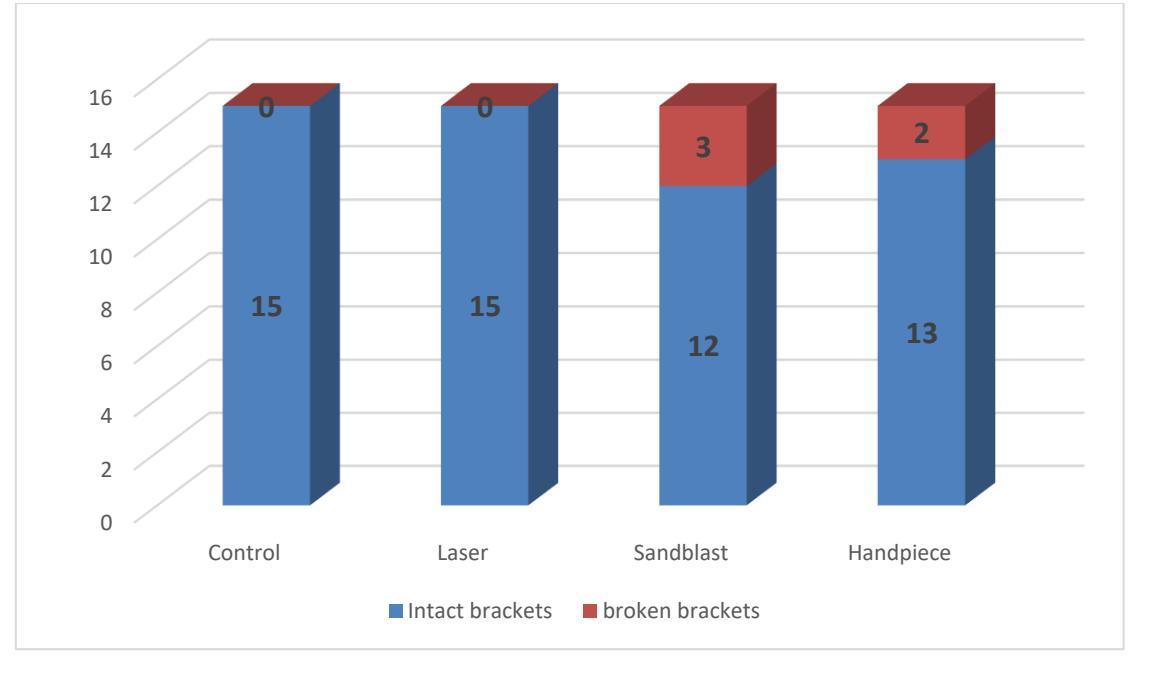
Figure (4): Bar-chart showing the frequency distribution of intact and broken Brackets

Three brackets were broken upon loading in the universal testing machine among the Sandblast group and two brackets among the Handpiece (Carbide bur) group. There are no broken brackets in the control or laser groups (Figure 4).

The sandblasting group showed lower shear bond strength results than laser group. It is also important to mention that three brackets were debonded from teeth upon loading to the universal testing machine. This lower bond strength mean values in the current study could be contributed to the destruction of the brackets base by sandblasting, as supported by few studies as Yassaei S et al [15] who noted remarkable micro-roughening of the base of the bracket was apparent after adhesive removal by sandblast although they concluded that sandblasting was efficient to mechanically recondition retentive ceramic brackets.

Regarding the adhesive removal by handpiece and carbide bur group, the current study showed lowest bond strength mean values in comparison to the control group, Er,Cr:YSGG laser group and sandblast group. Also, two brackets were debonded from teeth upon loading to the universal testing machine. This could be related to the significant reduction in the retentive areas of the brackets base, because of the incomplete removal of the adhesive, in addition to the distortion of the mesh structure.

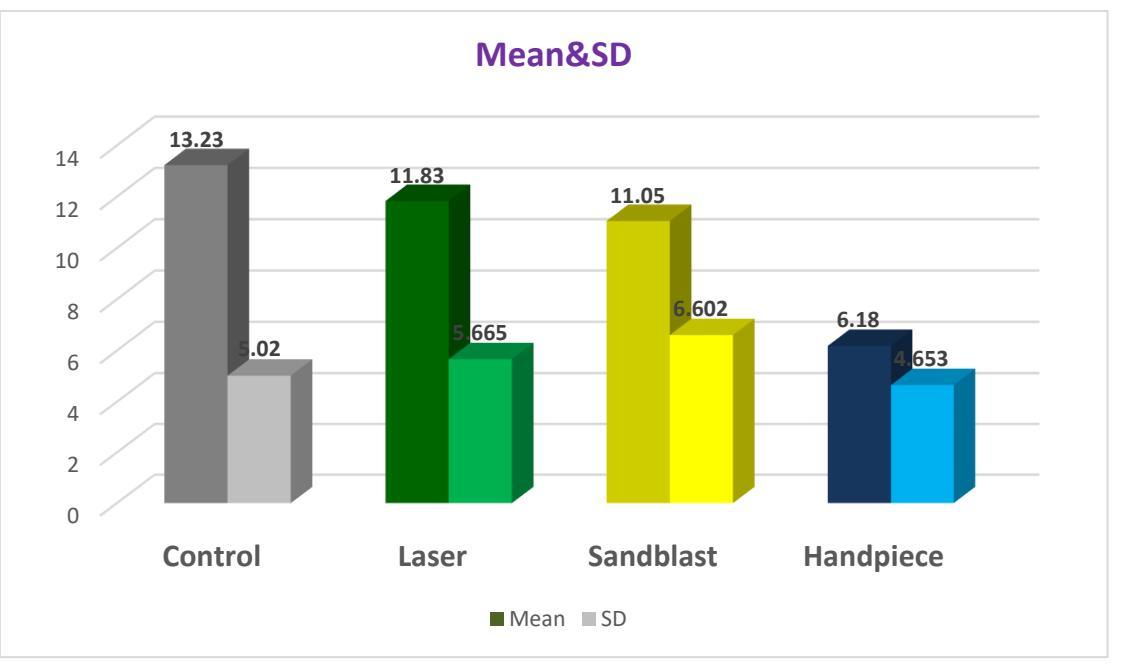
There was a statistically significant difference between shear bond strength of the four groups (P-value=0.006) (Table 2 & Figure 5).

Pair wise comparison between four groups revealed highest mean (13.2302MPa) shear bond strength with statistically significant difference between control group and handpiece (carbide bur) as it has showed the smallest mean (6.1863MPa) (P-value=0.002).

While there are no statistically significant difference between Control group vs Laser group (P-value=0.254) and Sandblast group (P-value=0.188).

The results of the current study showed that there was a statistically significant difference between shear bond strength of the four groups (P-value=0.006).

The control group had the highest mean shear bond strength (13.2302 MPa) followed by Er,Cr:YSGG laser group with a mean shear bond strength (11.8348 MPa), followed by the Sandblast group that showed a mean shear bond strength (11.0537 MPa), While the adhesive removal method by handpiece with carbide bur showed the lowest shear bond strength (6.1863 Mpa).

Pair wise comparison between four groups revealed statistically significant difference between control group and handpiece (carbide bur) (P-value=0.002), While there are no statistically significant difference between Control group and Laser group (P-value=0.254) and Sandblast group (Pvalue=0.188).
