## The Effect of Nano- $\text{ZrO}_2$ and nano- $\text{Al}_2\text{O}_3$ Reinforcement on Flexural and Impact Strength of Repaired Acrylic Denture Base

Yasmeen F. Al-Mahdy<sup>(1)</sup> and Heba E. Eltayeb<sup>(2)</sup>

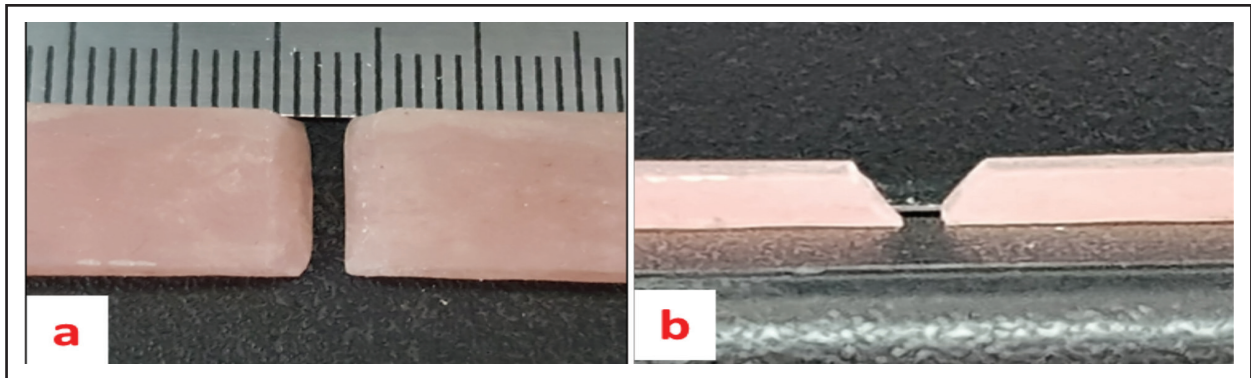
Fig. (1) Repair gaps of specimens. a: flexural strength specimen, b: impact strength specimen

The prepared intact specimens were cut vertically in half along their long axis by a high-speed diamond disk cutter under copious irrigation. For the flexural strength specimens, 2.5 mm was marked on the right and left from the center line on the top to create a repair gap of 5 mm on the top, and 1.25 mm was marked on the right and left from the center line at the bottom to create a repair gap of 2.5mm in the bottom. For the impact strength

specimens, 5 mm was marked on the right and left from the center line on the top to create a repair gap of 10 mm on the top, and 1.25 mm was marked on the right and left from the center line at the bottom to create a repair gap of 2.5 mm in the bottom (Figure 1 a,b). The prepared intact specimens were then cut in accordance with the markings on the specimen until a 45° bevel joint was created between the two pieces. To standardize the 45° bevel joints, a digital caliper was used to evaluate pairs of repair group specimens according to the required dimensions.

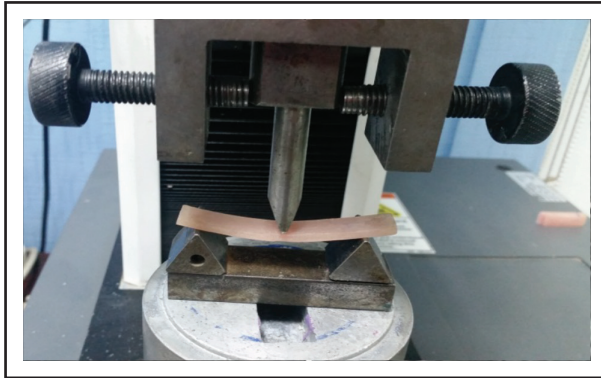
Fig. (2) Instron testing machine during Flexural strength test

All samples were individually and horizontally mounted in a custom made loading fixture [three point bend test assembly; two parallel stainless steel rods with span length of 50 mm supporting the specimen, with the damage site centrally located on the tensile side] on a computer controlled materials testing machine (Model 3345; Instron Industrial Products, Norwood, MA, USA) with a load-cell of 5 kN and data were recorded using computer software (Instron® Bluehill Lite Software). The load was applied perpendicular to the center of the repaired area until fracture at a crosshead speed of 5 mm/min (Fig. 2). The Stress-strain curves were recorded and the value of flexural strength (FS) of each specimen was calculated using the following formula:

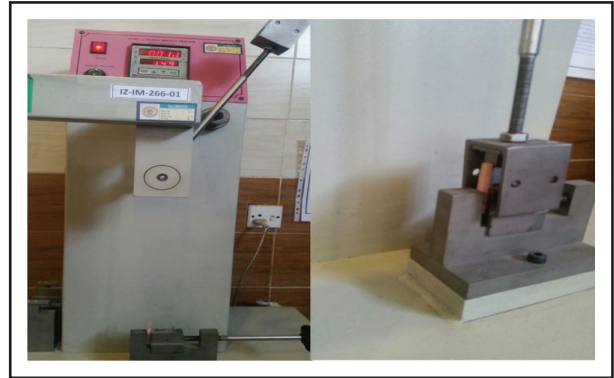
Fig. (3) Izod/Charpy Digital Impact tester during impact strength test

The impact strength of the specimens was measured by IZOD type of impact testing using Izod/Charpy Digital Impact tester (IZ-IM-266-01,

International Equipments). The samples were clamped vertically in a metal fixture so that the middle of the sample at the notch coincided with the striking pendulum. The pendulum struck the specimen at the notched side until fracture was obtained. The test was performed with 0.5 J pendulum and a 150° lifting angle. The energy required to break the sample was measured in Joules (Fig. 3). Impact strength (IS) in KJ/m<sup>2</sup> was then calculated by the device's software using the following formula:

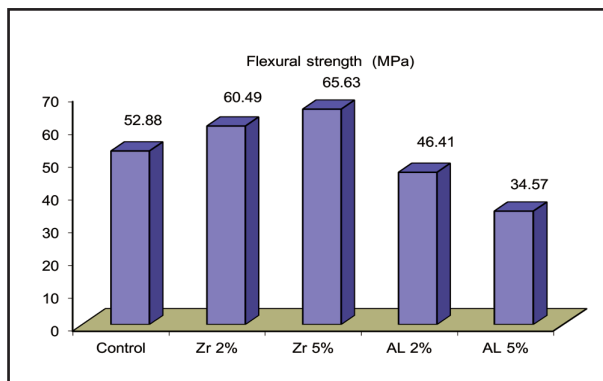
Fig. (4) Flexural strength results of study groups

The mean and SD of flexural strength of the specimens are summarized in Table (2) and Fig.(4). The statistical analysis showed that the flexural strength increased significantly in the nano-ZrO<sub>2</sub> groups than the control group and also the flexural strength increased with the increasing of the concentrations of nano-ZrO<sub>2</sub> significantly ( $P < 0.01$ ). The highest flexural strength was recorded for the 5% nanoZrO<sub>2</sub> fillers repair group (65.63±1.46 MPa), followed by the 2 % nano-ZrO<sub>2</sub> group (60.49±1.4 MPa) which also recorded higher significant mean value than the control group (52.88±1.35 MPa).

In both nano-Al<sub>2</sub>O<sub>3</sub> groups, there was a highly significant reduction in the flexural strength where the repair group reinforced with 2% nano-Al<sub>2</sub>O<sub>3</sub> recorded (46.41±1.55 MPa) and the repair group with 5% nano-Al<sub>2</sub>O<sub>3</sub> showed the lowest flexural strength (34.57±1.48 MPa) compared to the control group.

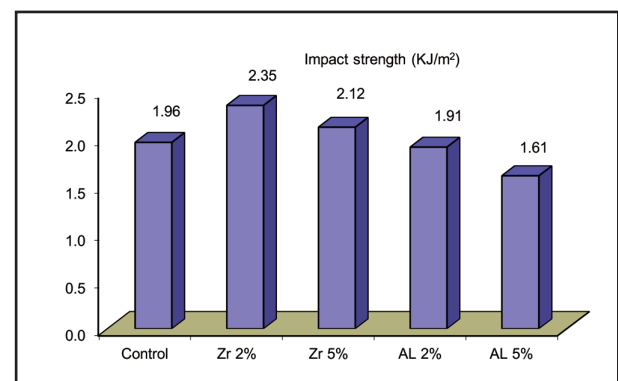
Fig. (5) Impact strength results of study groups

Table (4) and Fig. (5) show the mean and SD of impact strength for the tested groups. The mean values of nano-ZrO<sub>2</sub> repaired groups were significantly higher than those of the control group ( $P < 0.01$ ). The highest impact strength mean value was recorded for the 2% nanoZrO<sub>2</sub> fillers repair group ( $2.35 \pm 0.04$  KJ/m<sup>2</sup>) followed by the 5 % nano-ZrO<sub>2</sub> group ( $2.12 \pm 0.11$  KJ/m<sup>2</sup>) which also recorded higher significant mean values than the control group ( $1.96 \pm 0.04$  KJ/m<sup>2</sup>).

Regarding the 2% nano-Al<sub>2</sub>O<sub>3</sub> repair group, there was a non-significant difference in the impact strength mean values ( $1.91 \pm 0.10$  KJ/m<sup>2</sup>) than the control. While the repair group reinforced with 5% nano Al<sub>2</sub>O<sub>3</sub> showed significant reduction in mean values ( $1.61 \pm 0.06$  KJ/m<sup>2</sup>) than the control group and it showed the lowest impact strength value.
