*M.Sc. thesis abstract***Landscape Design Studies of Al Shallalat South Garden in Alexandria**

Mona Mahmoud Mohamed El-Hawy¹, Tarek Mahmoud Elkiey¹, Mohamed Hesham Soady², Hoda El-Sayed Mustafa Elmokadem¹

¹ *Department of Floriculture, Ornamental Horticulture and Landscape Gardening, Faculty of Agriculture, Alexandria University, Alexandria, Egypt*

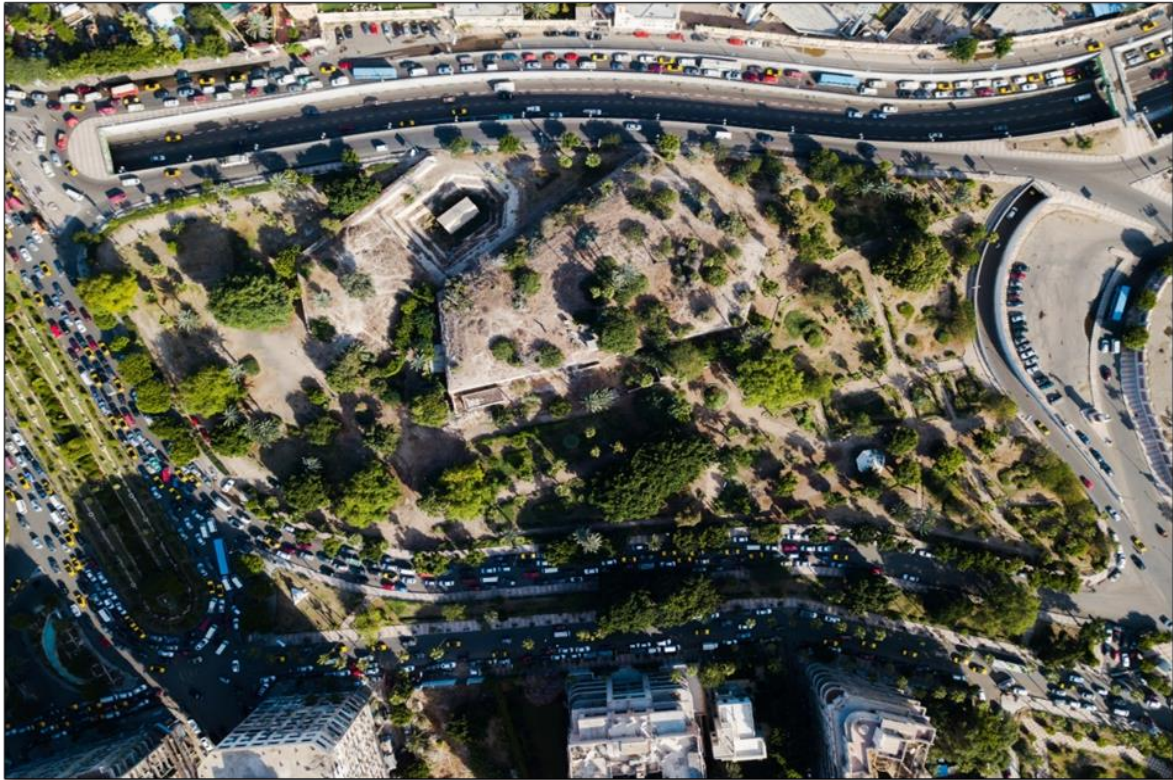
Fig. 2. Arial image by Drown showing Al Shallalat's south garden and its borders. By author.

Al Shallalat Gardens are Alexandria's third-largest park, considered a heritage park. So there is an urgent need to protect these gardens in proper condition. Al Shallalat Gardens were divided into the northern one called El Bahariya and the southern one called El Qebleya section. This study was carried out in the southern section of Al Shallalat Gardens. AL Shallalat's south garden total area is 32600 m². Its borders are Abou Quer Street and Watch Square at the north, Omar Toson Street and Alexandria Stadium at the south, Suez Canal tunnel {AbdelMoneim Riad Tunnel} at the east, and Salah Mustafa Street at the west (Figure 1). In this study, the location of Al Shallalat's south garden is analyzed in all aspects and made a questionnaire to take the people's opinion of Al Shallalat's south garden, a historical green space deserted and underutilized despite its central and accessible location in the city, to determine the real reasons for disusing the garden to propose a development program capable of pushing the garden to attract people and achieve the best performance. Results of the questionnaire analysis and site observations showed the problems that the garden is suffering from as follows (Figures 2 and 3):

- 1) Lack of public awareness of the importance of the garden as a historical garden.
- 2) Neglecting the maintenance of historic buildings.
- 3) Lack of maintenance of plants as well as the hedges are unpleasant and make the garden look divided and smaller.

- 4) Lack of plant variation, not enough colors, and limited to a few types of plants and their repetition, which led to a lack of botanical variety in the garden.

- 5) Lack of cleanliness and there is much rubbish in the garden
- 6) Most of the Seats are broken and not enough.
- 7) The fence is very low in height and incomplete which allows the entrance of the homeless and people who don't respect the laws.

- 8) Lack of safety and security.
- 9) There is no existence of facilities such as bathrooms - restaurants - cafes.
- 10) Lack of clarity paths and they are unpaved.

- 11) Lack of night lighting sufficiency, which made it a den of crime.
- 12) Lack of physical and social activities in the garden.
- 13) The heights are not being used in a proper way in the garden design.

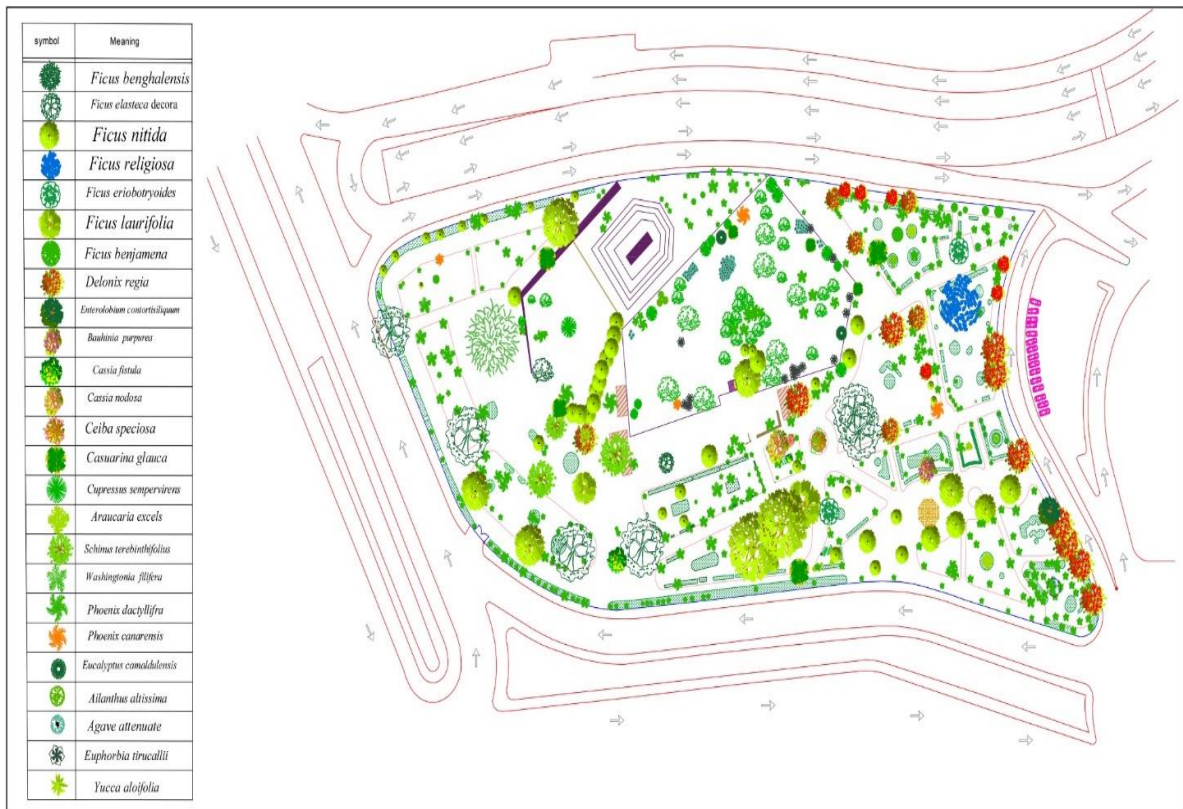
Fig 3. Al Shallalat south garden Layout showing the detailed components that include buildings and plants. Painted by AutoCAD program.

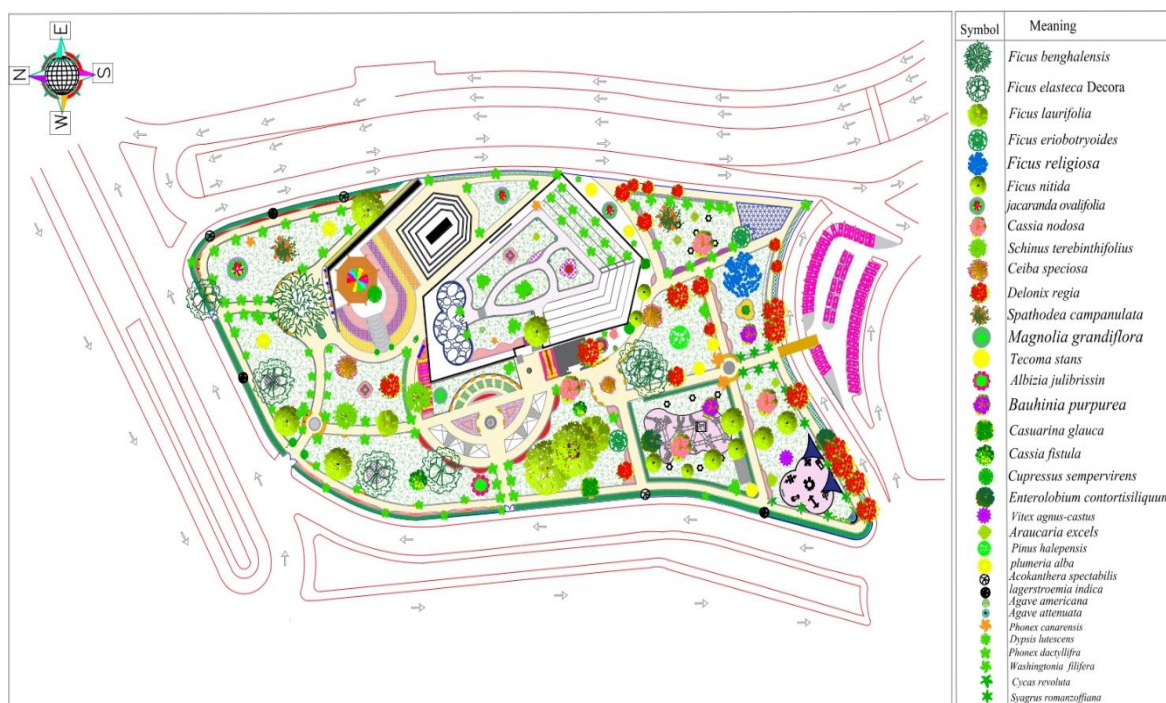
Fig 4. The proposed design Layout of Al Shallalat's south garden. Painted by the AutoCAD program.

The proposed design is a mixed style that contains straight and curved lines. It aims to create a public garden as a landmark. This study proposed increasing the green areas and adding new plants taking into account the variety and repetition of the chosen plants to provide visual interest for visitors and create patterns or sequences in the landscape. The proposed design is based on the exploitation of every part of the garden and highlighting the archaeological features in the garden and using them in the design as follows (figure 4):

1. Retaining the ancient plants and flowering plants as well as removing randomly grown diseased plants and unpleasant hedges
2. Adding new plants to create plant variation and adding more colors to the garden.

3. Provide enough open areas of lawns.
4. Paving the park paths to facilitate the movement of visitors and disabled people.
5. Attention to the well-maintenance of plants.

6. Attention to the maintenance of historical buildings and rebuilding the stairway that leads to the top of Tapia Muhammad Ali.
7. Attention to the cleanliness of the garden and add rubbish baskets.

8. Providing more than one entrance and the clarity of these entrances.
9. Completing the garden fence to be of an appropriate height to provide safety for the park's visitors. It should allow visual continuity from the street and also decrease opportunities for intruders to hide.

10. Providing good and sufficient lighting units to illuminate the garden
11. Equipping the garden with public toilets.
12. Provide comfortable and sufficient seats for visitors and distribute them along the park paths.

13. Adding the water element in the form of a fountain, waterfall, drinking fountain, and preserving watering birds by supplying them with water.
14. Adding a children's playground to attract visitors who have children.

15. Adding a cafeteria or restaurant to be rented to spend on the garden maintenance.
16. Benefiting from the car parking that is located next to the park by making a bridge connecting the parking to the park.

17. Providing information signs to guide visitors.
18. Provide an outdoor gym and Wi-Fi service to attract more people to visit the park.
19. Adding kiosks of bookstores and shaded seats next to them.

20. Providing an administration building instead of sporadic random buildings.
21. Using the heights that exist in the design and not ignoring them.
