## **Restoring the Vertical Dimension in Case with Missed Posterior Teeth and Severe Attrition: A Case Report**

### **ABSTRACT**

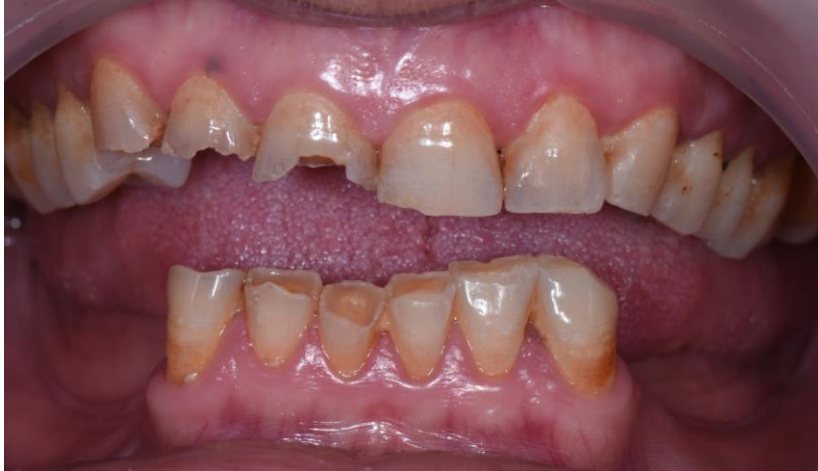
A 62-year-old woman came for treatment of sever attrition. Her main complaint was that she had difficulty eating anything since her lower posterior teeth had fallen out and her anterior teeth had worn down. She was diabetic and taking an analgesic for idiopathic head pain. Intraoral assessment showed a localized anterior loss of tooth substance in the upper and lower dentition, with the maxillary upper right anterior teeth showing the most loss. Because the mandibular posterior teeth were absent, the upper anterior teeth had sharp enamel borders and attritional wear. **Figure 1.**

**Figure 1.** Teeth attrition due to loss of posterior support

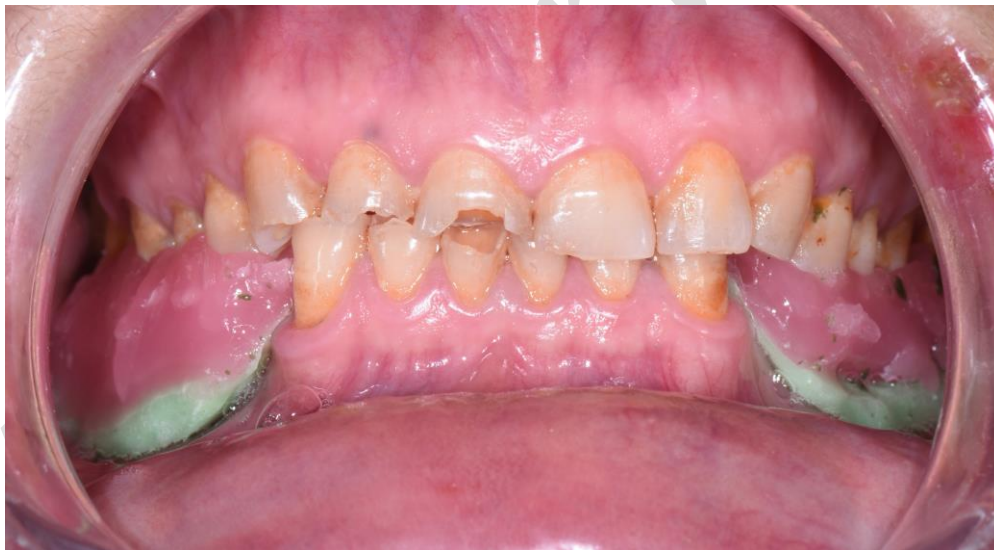
. The patient's centric relation (CR) record was taken by using the 'bimanual manipulation technique where the clinician was directly behind the supine patient with the patient's chin pointed upwards. The clinician gently helps guide the mandible into the CR by placing their thumbs on the patient's chin and fingers on the lower border of the mandible in presence of mandibular trial denture base and occlusion wax blocks **Figure 2**.

**Figure 2.** CR record by trial denture base and occlusion wax blocks

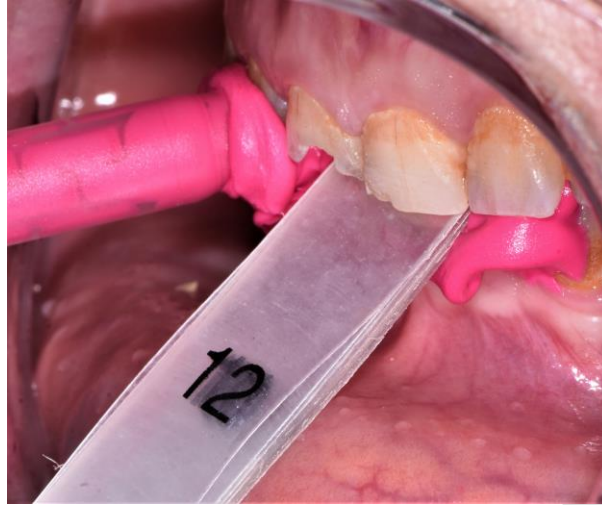
The patient's casts were fixed on a semi-adjustable articulator and a face-bow record and an interocclusal record were made with the aid of occlusal bite registration material. The new VDO was set by increasing it by 1.2 mm using the leaf gauge **Figure 3**. VDO was increased not by a standardized esthetic golden proportion of anterior teeth, but by physiologic factors such as interocclusal rest space and speaking.

**Figure 3.** Leaf gauge used to determine the new VDO

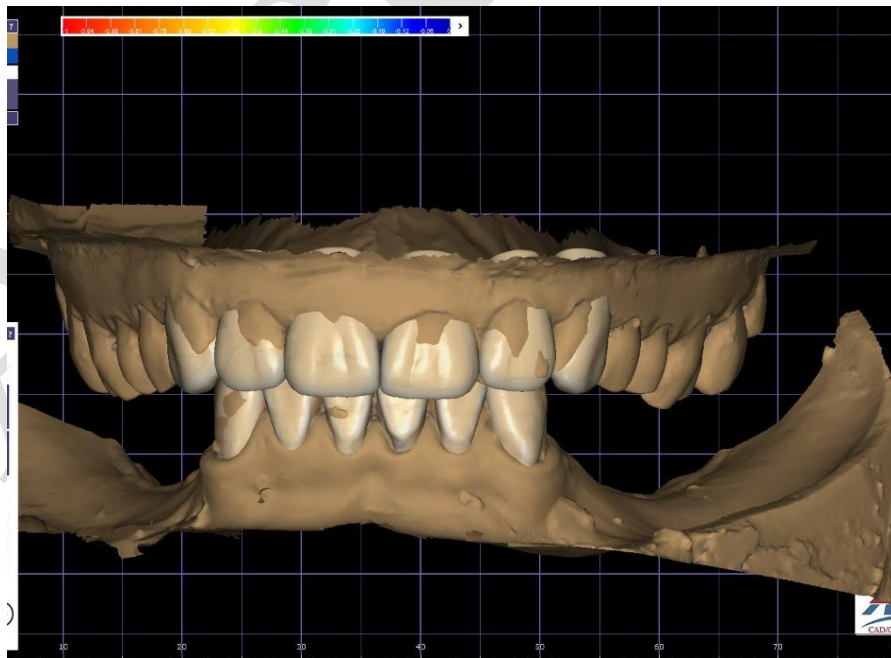
Scanning for the mounted casts was done and smile design was done for upper and lower anterior teeth in the new vertical dimension to ensure that the gained space was enough for the new restorations **Figure 4**. After the proper design, 3D-printed upper and lower arches were fabricated and a rubber base index was fabricated for each arch for the temporization step.

**Figure 4.** Smile design for upper and lower anterior teeth

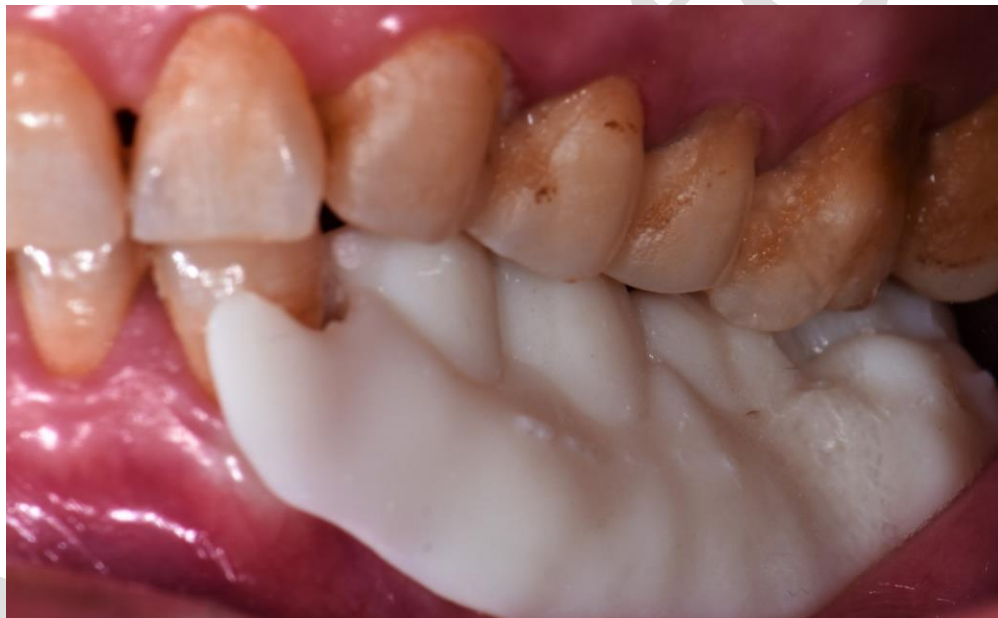
The mandibular provisional RPD was designed in the new customized vertical dimension to act as a posterior occlusal stopper to maintain the anterior space for anterior mockup restorations **Figure 5**.

**Figure 5.** Mandibular provisional RPD

The patient was told to keep the RPD in place for three months. During this time, the patient's state and functions were assessed, including muscle discomfort TMJ pain, mastication, the range of mandibular motions, swallowing, and speech. Mastication and speech enhancement verified the patient's acceptance to the new mandibular position with the restored VDO.

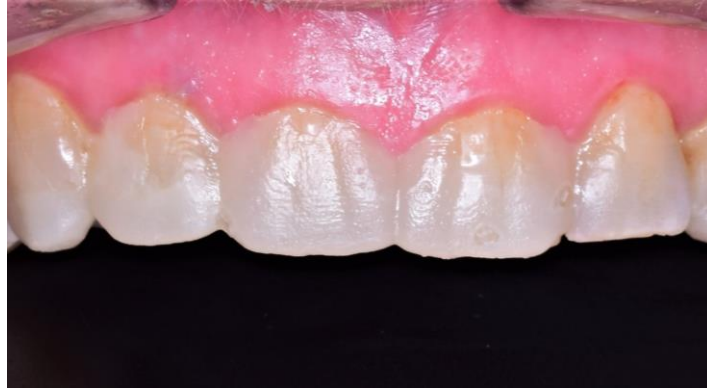
Rubber base index was used for each arch to fabricate the temporary anterior restorations by using (*Provi Temp K*) resin material. The temporary restorations were modified and utilized as a guide for the final oral rehabilitation **Figure 6**.

**Figure 6.** Mockup for the upper anterior teeth

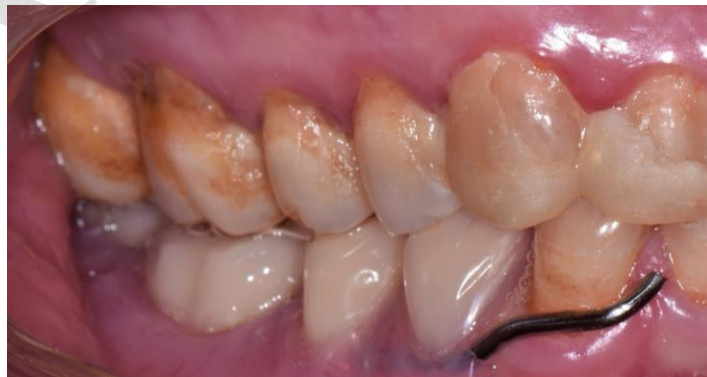
Following the wax denture trial, the final mandibular RPD was manufactured and delivered with little occlusal modification. The posterior molars supported the bite force and oral hygiene instruction, as well as regular check-ups **Figure 7.**

**Figure 7.** Definitive mandibular RPD

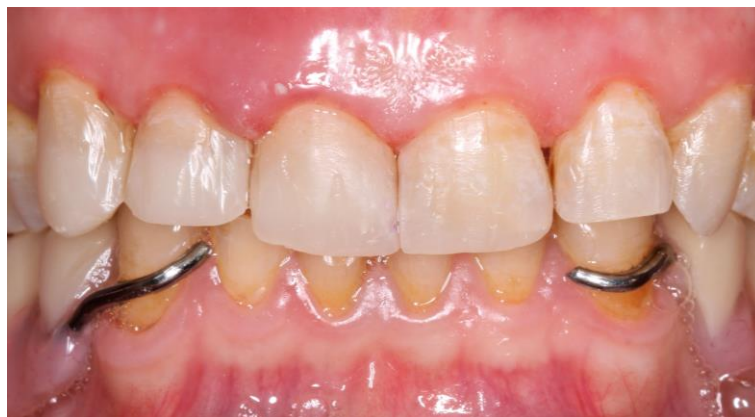
Final cavity preparation was performed, and definitive resin composite restoration was done in the upper and lower anterior teeth. Multi-shading restorations were fabricated in the upper arch by using (*z350 xt 3M ESPE*) nano-filled resin composite (Enamel A3 and Body A2)

**Figure 8.** Definitive resin composite restorations
